BETHEL, VERMONT

MIDDLE WHITE RIVER AND THIRD BRANCH WATERSHEDS

STREAM GEOMORPHIC ASSESSMENT and RIVER CORRIDOR PLAN

2013-2014 December 24, 2014

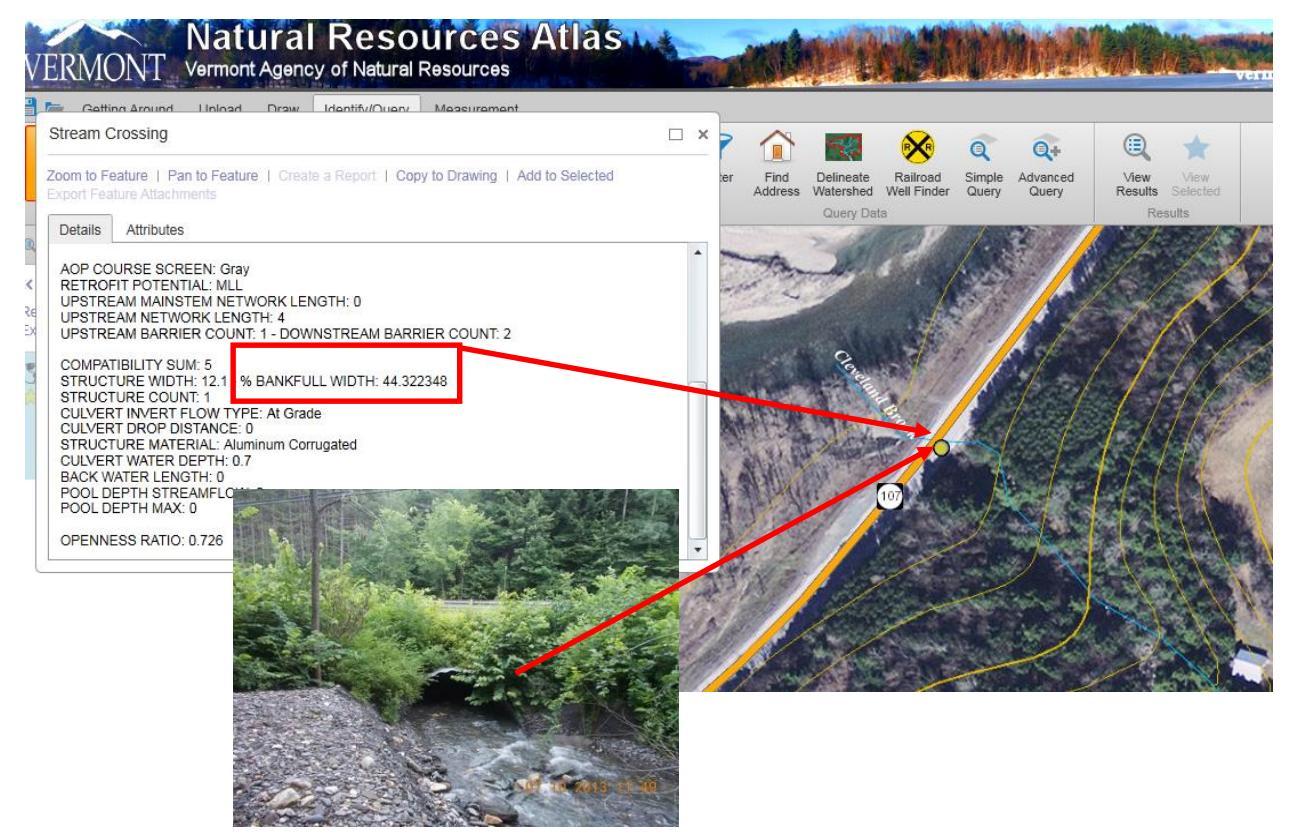
Figure 20. Undersized culvert under Route 107 sits at slope break contributing to alluvial fan sedimentation in the culvert as well as sediments that washed over the road during Hurricane Irene; the structure did not appear to have been damaged in Irene.

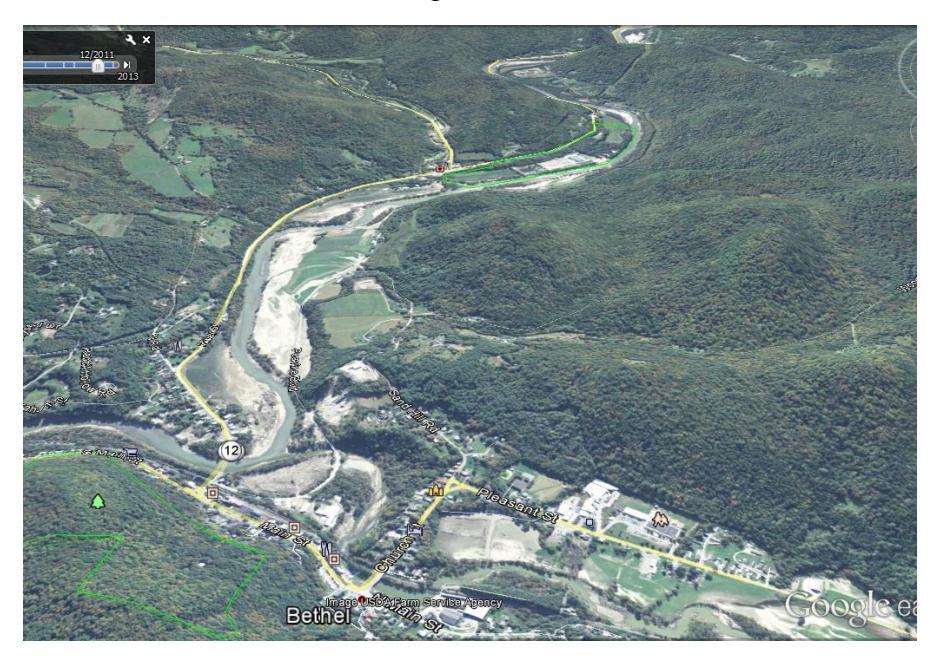
Figure 36. Although mainstem reaches of the White and Third Branch had only "moderate" levels of sediment loading in the channel following Irene, these areas had heavy deposition on the floodplains-as evident in this September 2011 view up the White mainstem west-southwest of Bethel. National Fish Hatchery outlined in green at top of photo was covered with heavy sediment as well.

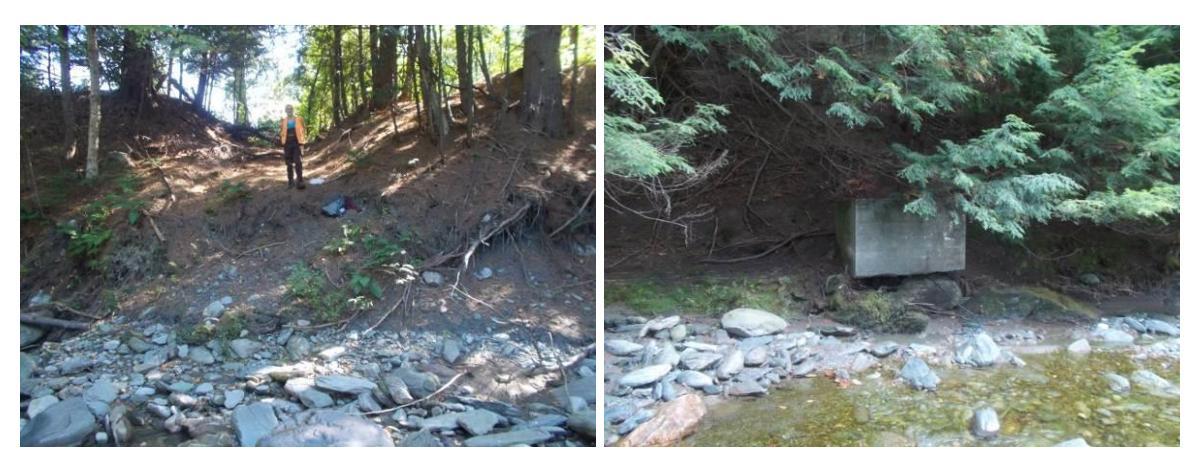
Figure 46. Stream ford on Lilliesville Brook (left) and spring box on Camp Brook (right) indicate depth of recent channel incision that lowered the stream bed in relation to this infrastructure.

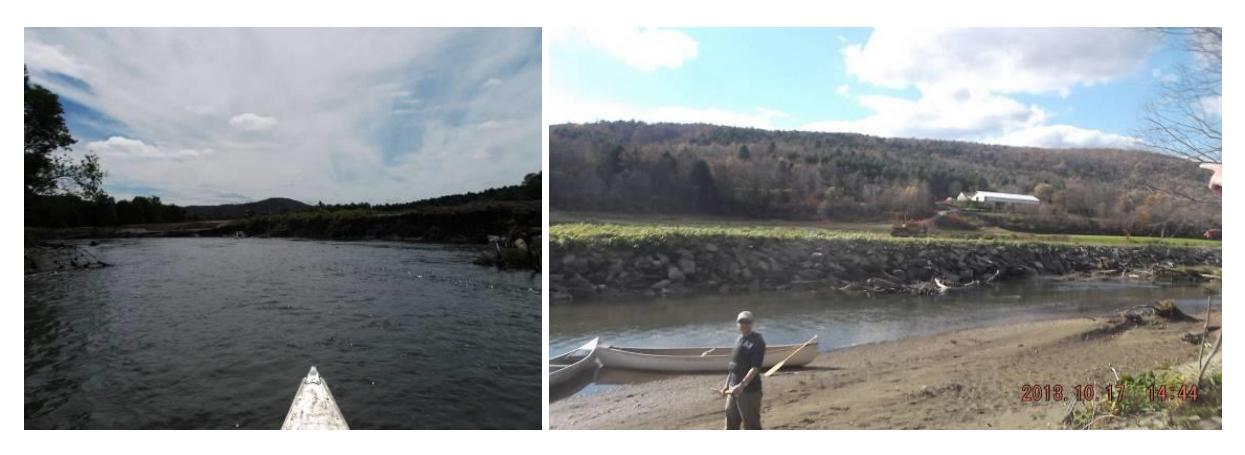
Figure 60. Bank along the neck cut-off was roughly 8 ft. high and completely eroded in August 2013 (left) and by October 2013 had been riprapped (right) with relatively small stone that is likely to be subject to failure in future high flows along this dynamic reach.

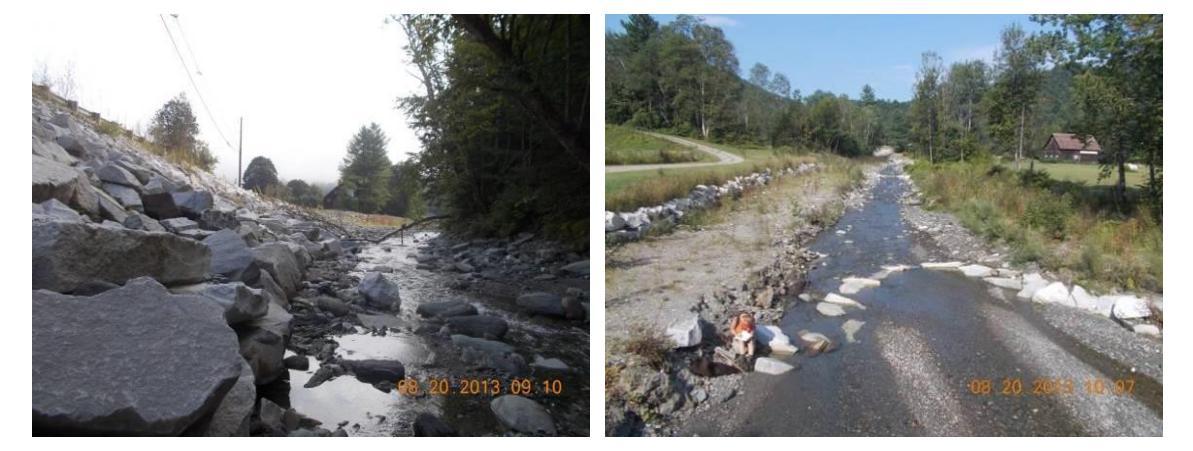
Figure 62. Left and right: M01S3.01A encroachment is common, as seen with road work, new riprap following Irene storm damages, and house located in the floodplain. Right: View from the Route 12 bridge shows post-Irene mitigation including rock weirs constructed to arrest head cutting in a dredged area. Scour was frequently noted in the vicinity of these weirs, but the photo (right) shows evidence of recent sedimentation. More difficult to see is a recent planting of native shrubs along the right bank where a new flood bench was created.

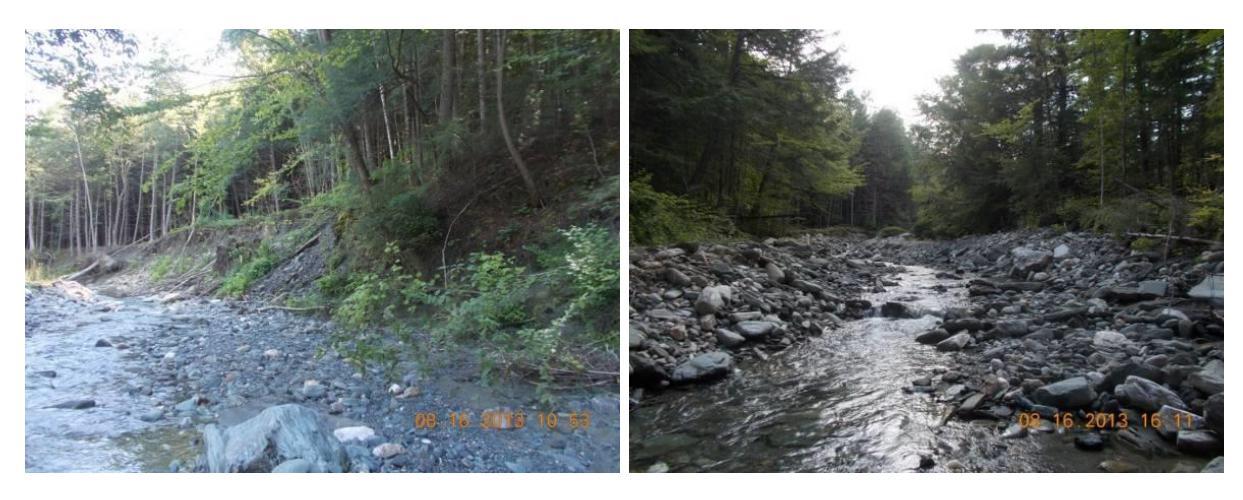
Figure 63. Left: Forested buffers and considerable bank erosion are common in M01S3.01B. Right: Stream channel after post-Irene dredging/windrowing.

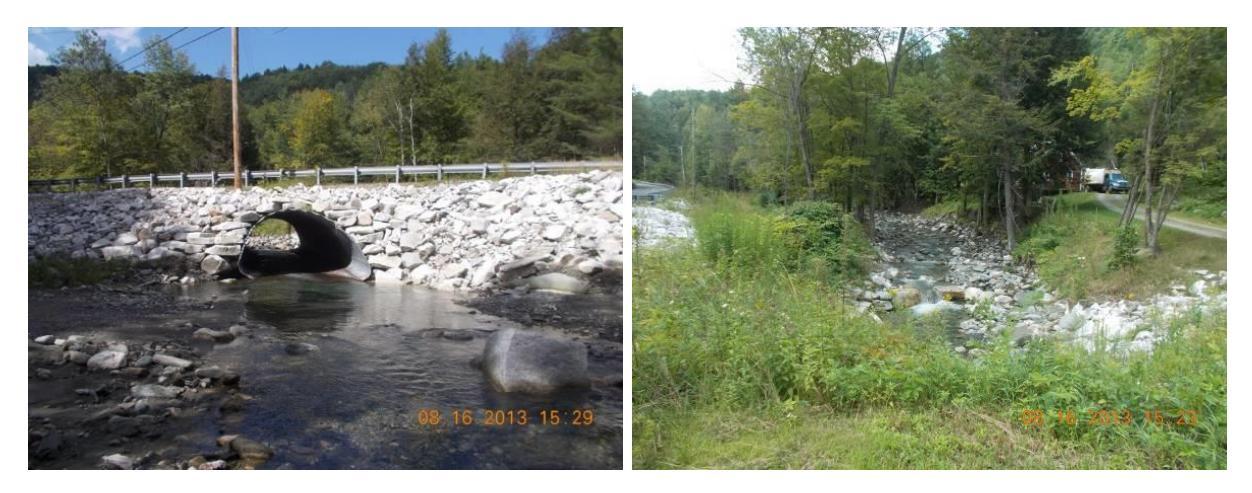
Figure 64. Left: New undersized culvert placed after Irene. Right: This landowner says the stream avulsed closer to Camp Brook Road (left in the picture) in a storm since Irene, and a road crew came and put it back in the original channel as seen here.

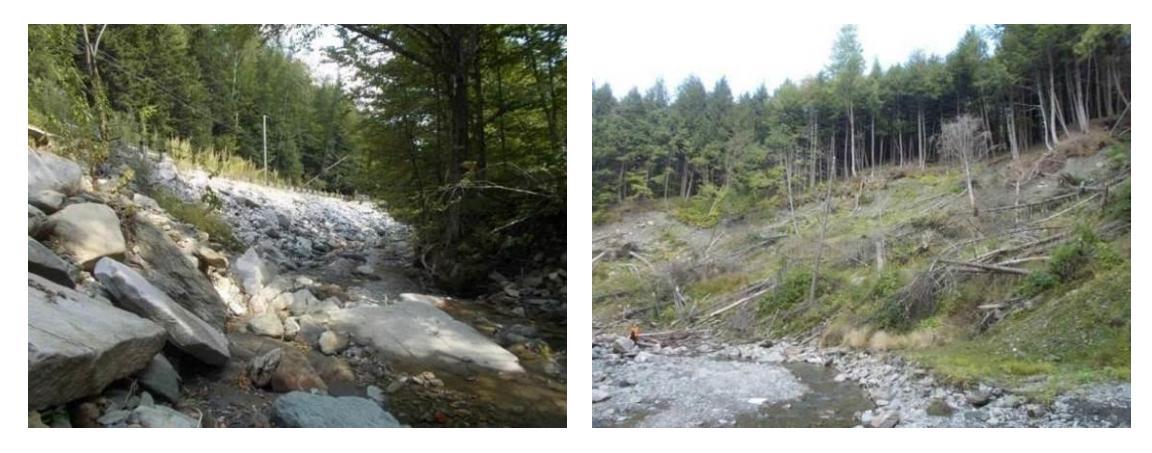
Figure 66. Left: Road encroachment typical of entire length of M01S3.02A; new riprap indicates Irene damage. Typical of this segment, riprap appears small and likely to wash in subsequent storms. Right: A particularly large mass failure in the downstream portion of Segment A.

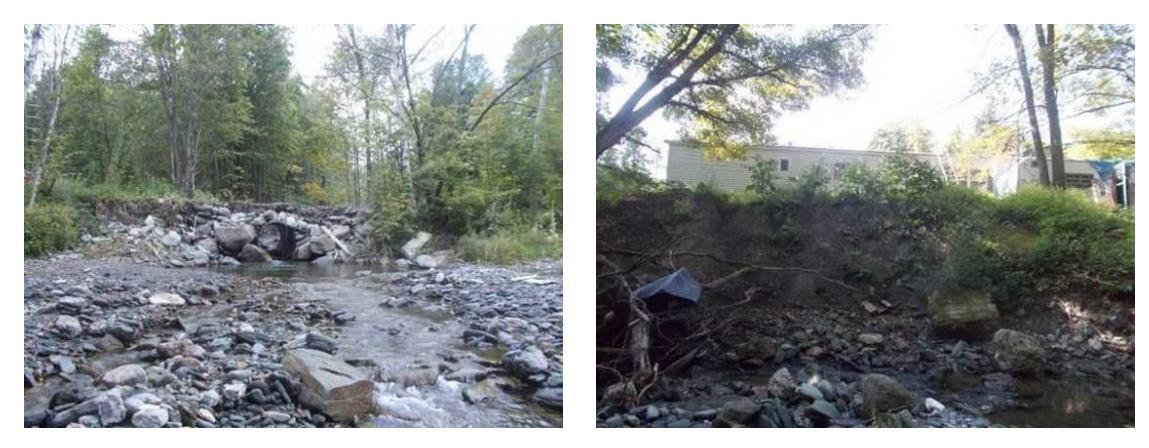
Figure 67. Left: New culvert to replace structure washed out in Irene is still very undersized and likely to wash again. Right: Development encroachment in the stream corridor of M01S3.01B.

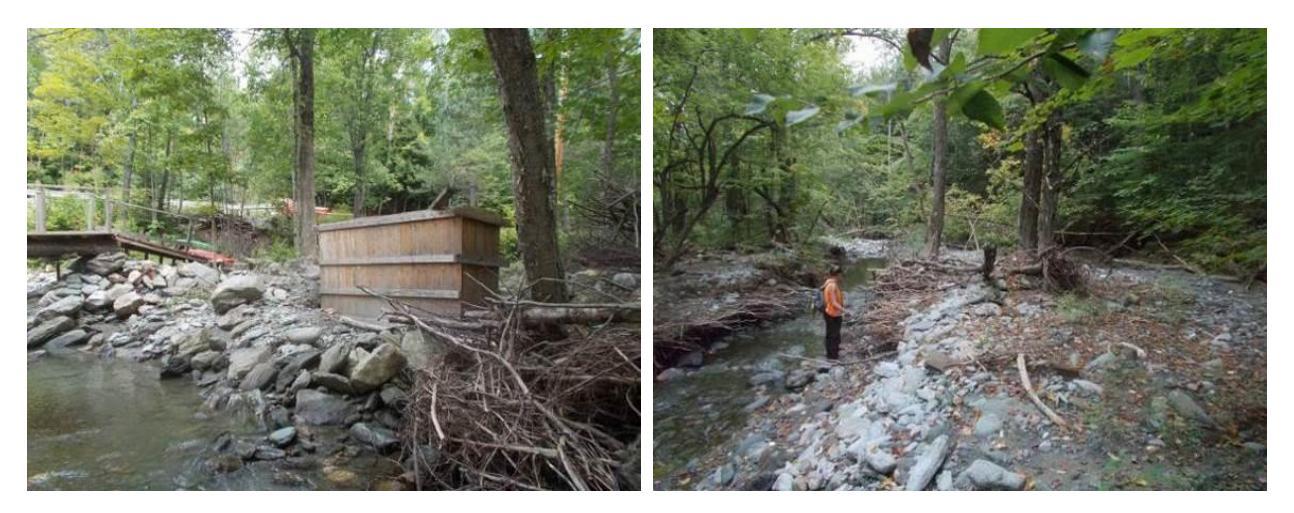
Figure 68. Left: Site of failed bridge in M01S3.01B with temporary footbridge (left) and abutment form (right), presumably for a new bridge. Right: Stream avulsion with old channel on the right.

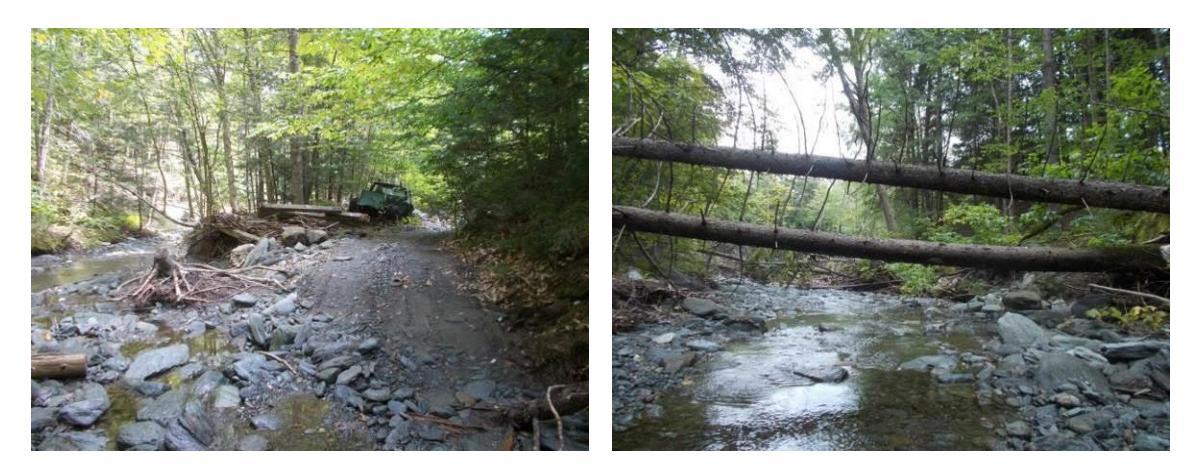
Figure 71. Left: Encroachment in segment M01S3.03A, with junk vehicles visible along a road along the right bank and signs of gravel mining and dredging in the stream channel. Right: Abundant woody material in this wider valley has created opportunities for debris jams and channel avulsions.

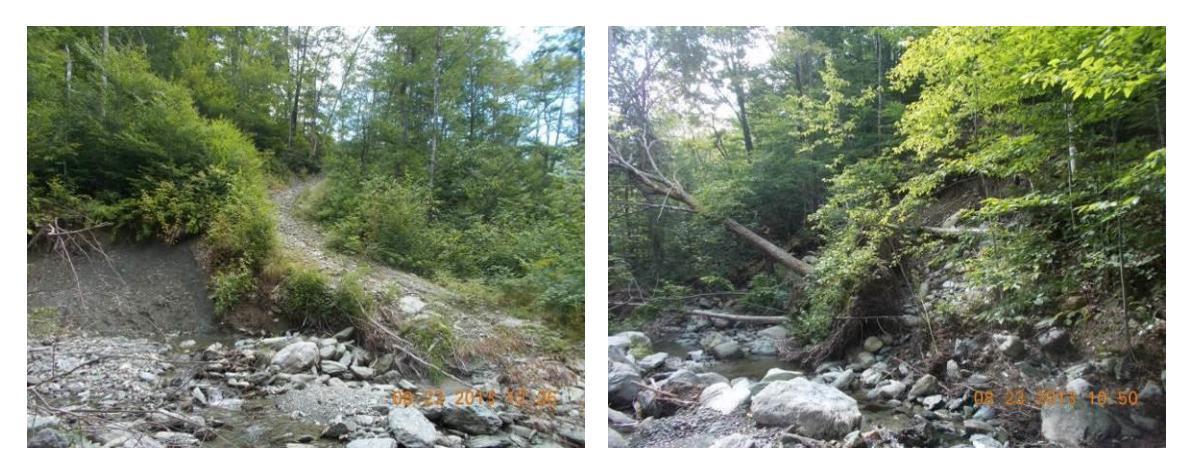
Figure 72. Left: Recent harvesting activity, including stream crossings, in segment M01S3.03B. Right: Mass failures are a common feature of this segment.

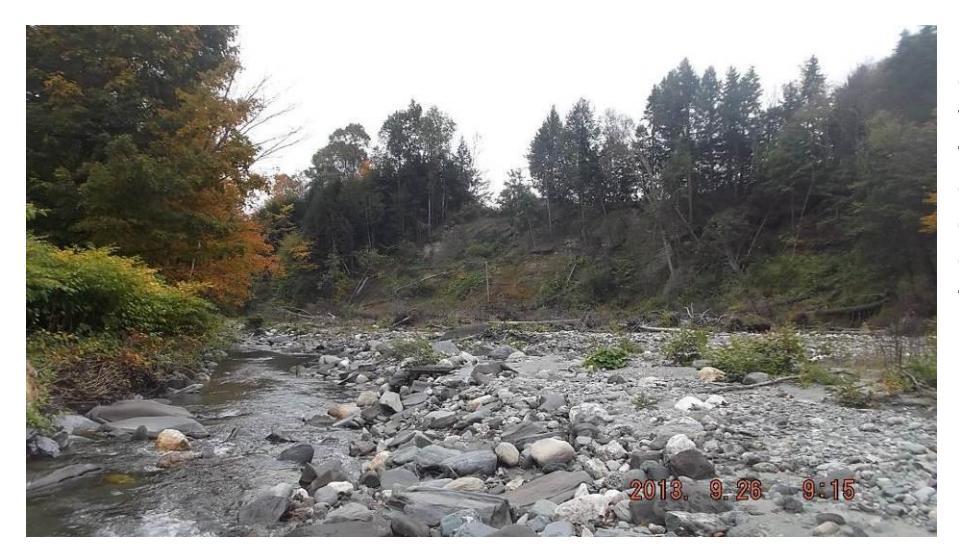
Figure 76. A small house or cabin sits high on the valley wall (center) above these mass failures exposing the extremely deep, highly erodible soils of segment T1.01A following Irene. The bridge across Gilead Brook to farm fields across from this former house location was outflanked on the left bank during Irene and has not been rebuilt (Fig. 77), as discussed further below in relation to segment T1.01B.

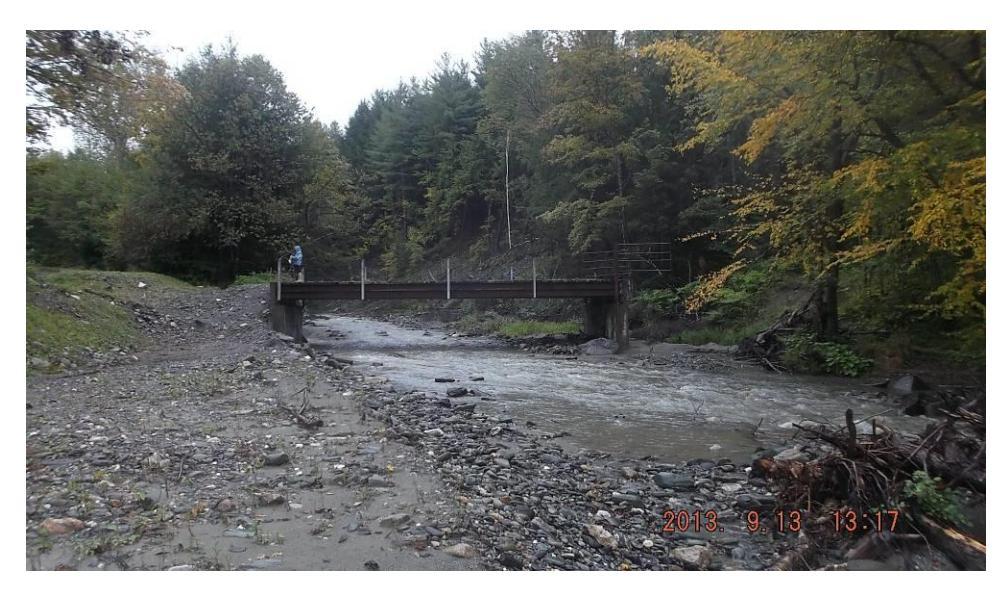
Figure 77. Spring Hollow Rd. bridge on the border of segments T1.01A and B was outflanked in Irene and has not been rebuilt; Spring Hollow Rd. is now gated at its entrance from Rte. 12.

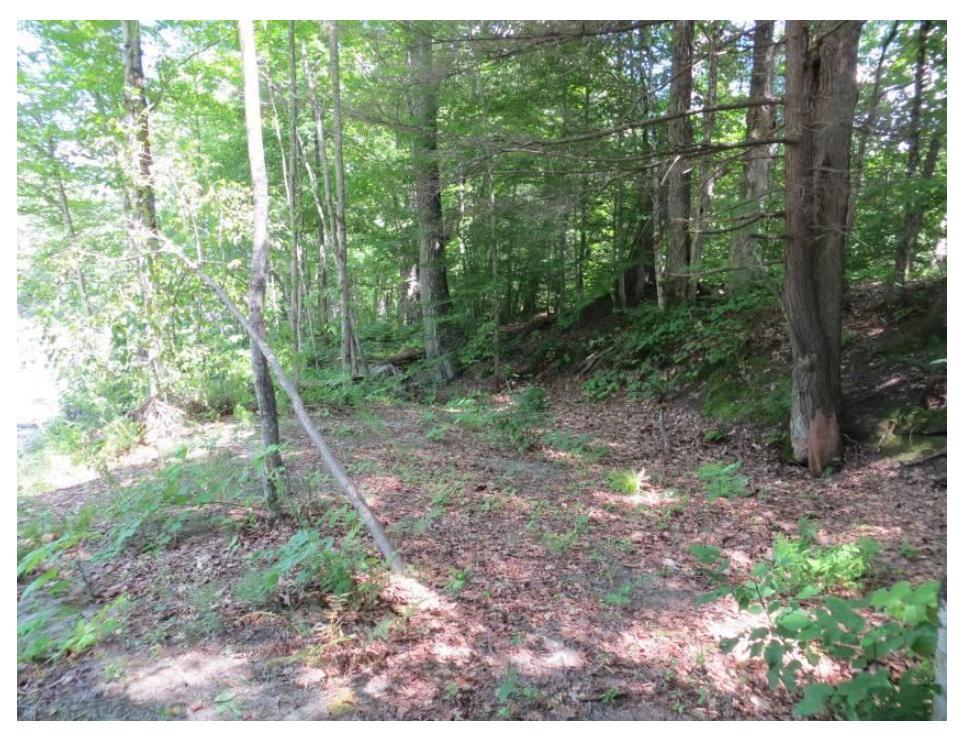
Figure 94. Trees along a 750 foot berm upstream of the White River National Hatchery appear to be significantly older than the Hatchery; post-Irene sediment deposition evident in this picture inside the berm was not observed outside of the berm.

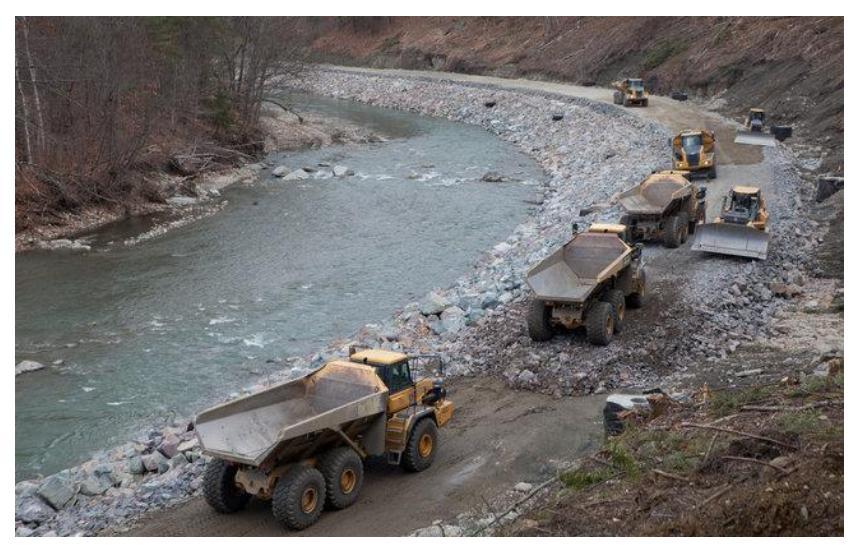
Figure 97. Reconstruction of Rte. 107 along the southern flank of reach R13 included hundreds of thousands of tons of stone hauled in to force the White River back away from the former roadbed it had incorporated into the stream channel. *Photo credit: Matthew Cavanaugh for The New York Times.* During the process of rebuilding Rte. 107, "A special "rock train" carts pink stone 100 miles from quarries near Burlington, and workers scoop washed-out stone and gravel from the river itself." (Schwartz 2011; Fig. 98).

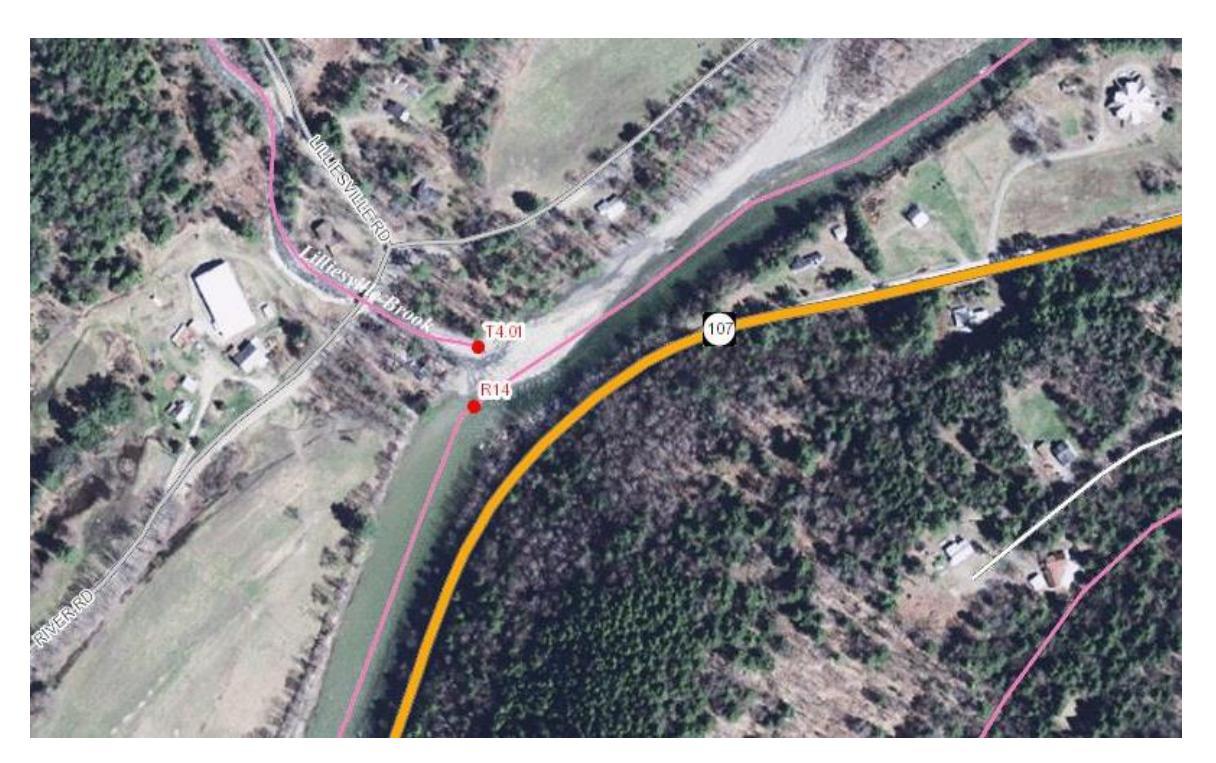
Figure 100. At the upstream end of reach R13, alluvial fan at the base of Lilliesville Brook has evidenced significant discharges of cobble sediments in multiple flood events – mostly recently following Irene as visible in the 2012 imagery above (map per VT ANR Natural Resource Atlas).

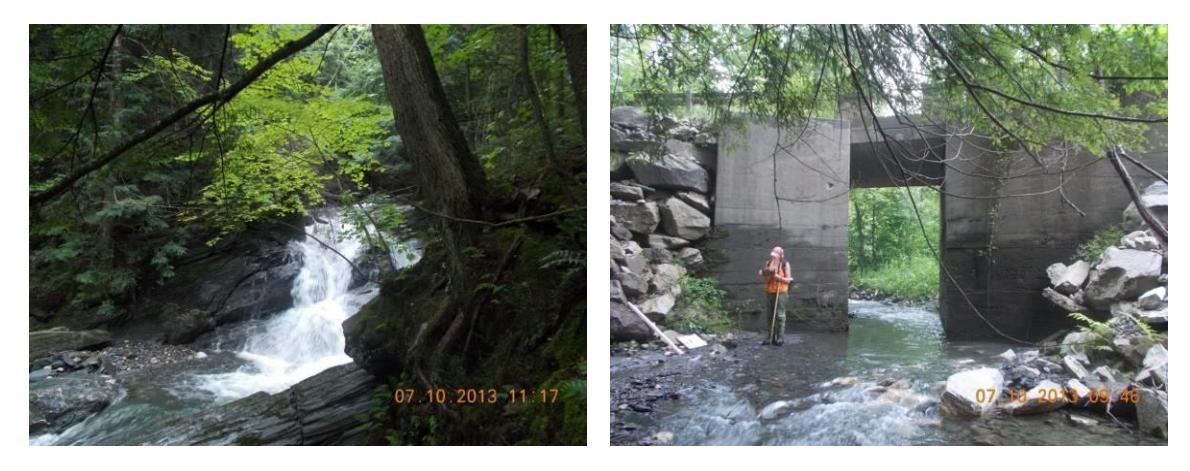
Figure 103. Left: Bedrock cascade is common in R12S2.01A. Right: The bridge at Cleveland Brook Road constricts this 34 foot channel to 7 ft..

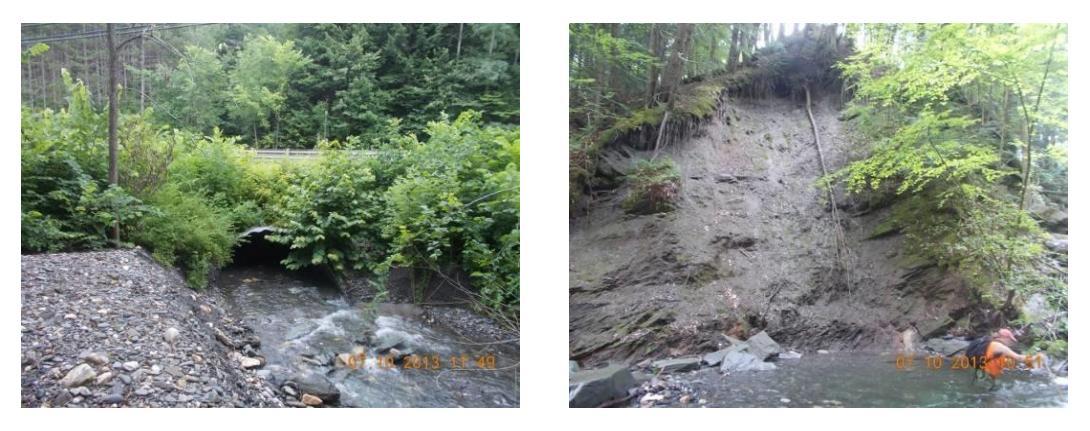
Figure 104. Left: the downstream side of the culvert under Rte. 107 shows sediment build up in the culvert as well as sediments that washed over the road during Hurricane Irene. Right: Mass failures are fairly common in R12-S2.01A, where valley walls are extremely steep.

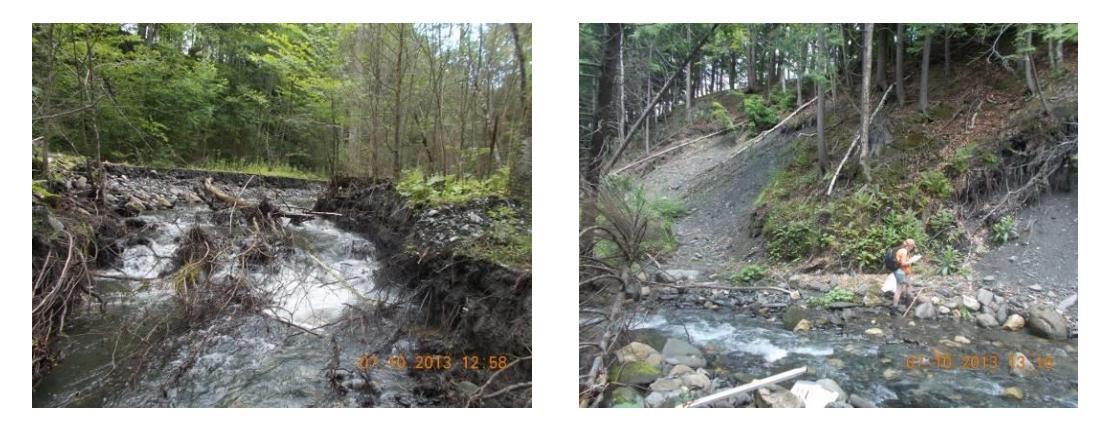
Figure 105. Left: Alluvial sediments upstream of the Cleveland Brook Rd. bridge in R12-S2.01B show signs of downcutting. As this area fills and then erodes, flushes of sediments can plug undersized downstream road crossings. Right: Mass failures typical of Segment B.

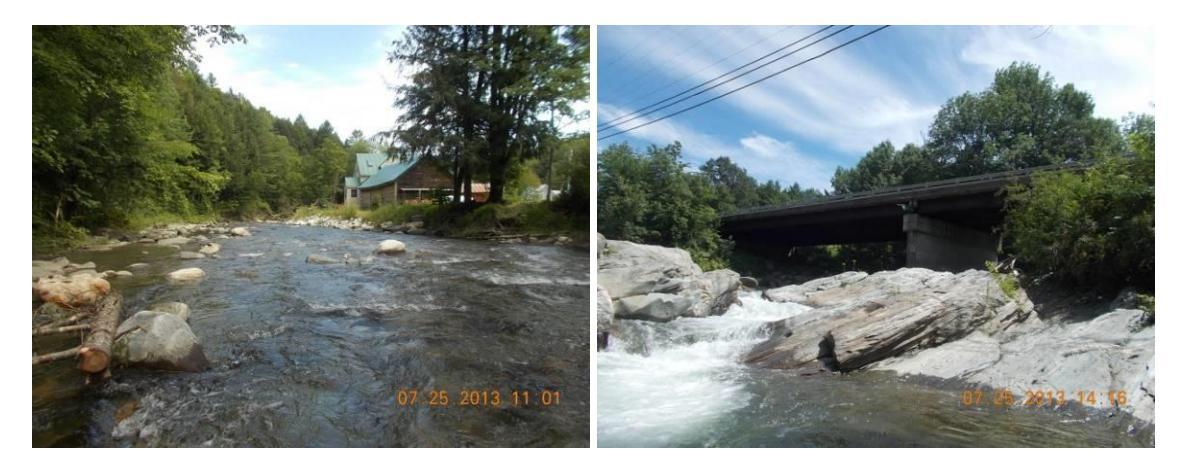
Figure 109. Left: encroachment on the right bank of segment T3.01A. House was rebuilt following Irene and is likely to be at risk again in future high flows. Right: Large bedrock grade control at the Rte. 107 bridge.

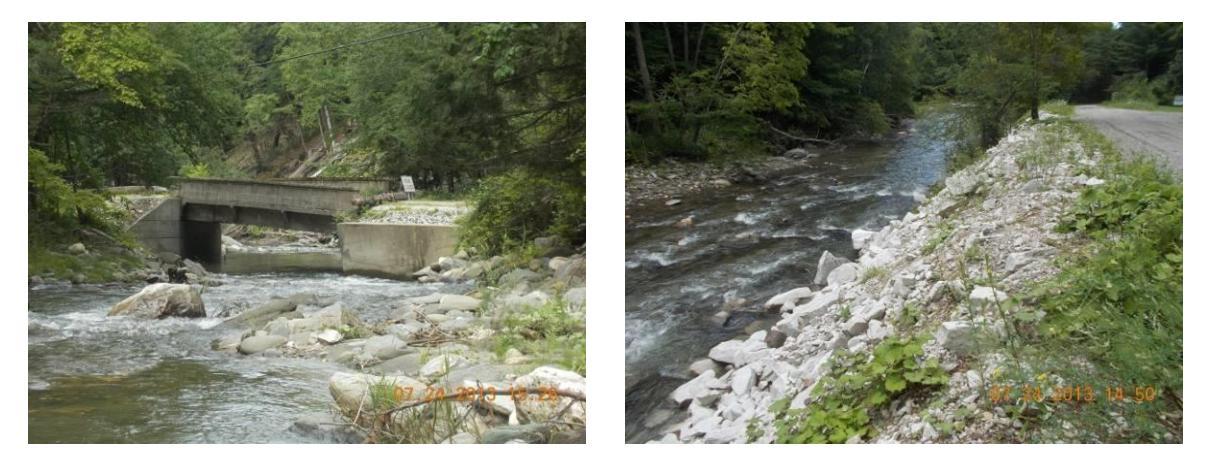
Figure 111. Left: Bridge failure during Irene has led to closing of Old Rte. 12 at this bridge. Right: Riprap common along segment T3.01B appears insufficiently sized to withstand damage in large storms.

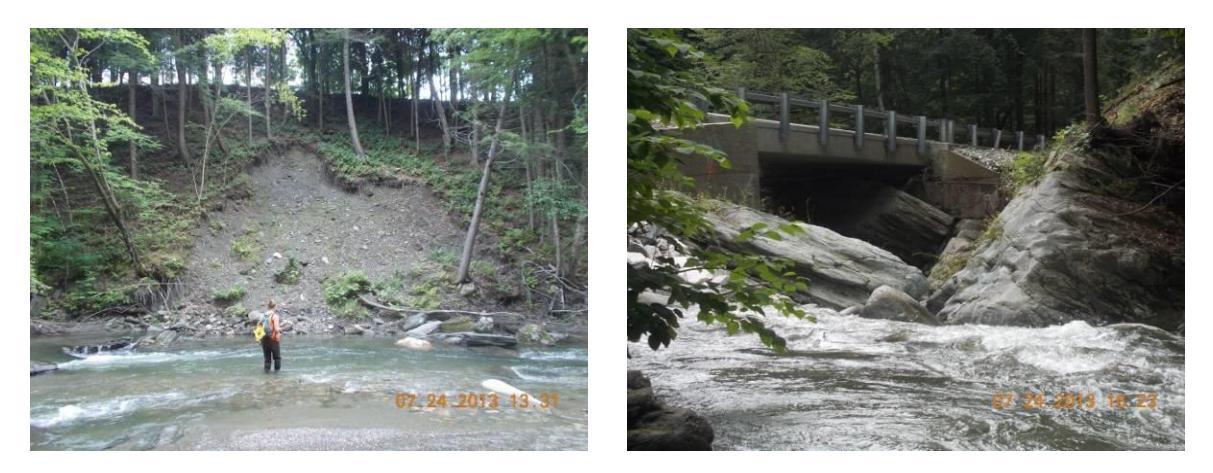
Figure 112. Left: Mass failures are a common feature in segment T3.01B, as is the absence of woody debris that would have been found in the stream following these mass failures. Right: This bridge is located on a section of bedrock grade control.

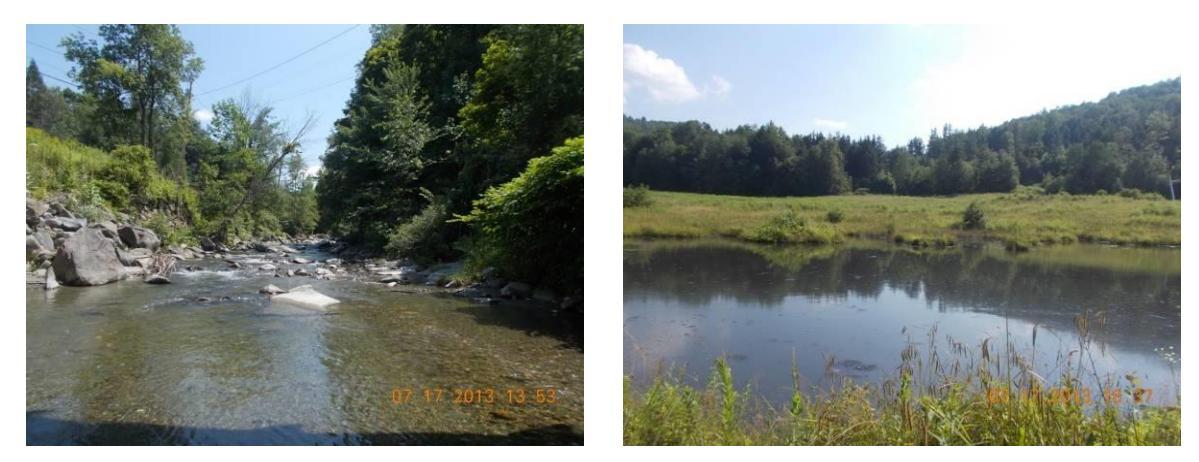
Figure 113. Left: Road encroachment along one side of the stream is typical of segment T3.01C. The road in this location is on an old terrace and gives a good indication of the level of incision and loss of flood plain access typical of this segment. Right: View of the wider natural valley and old farm fields in this area. The pond, constructed in the last 10 years, is only 100 ft. from the stream and is one of two ponds constructed in the last 20 years in this historic floodplain.

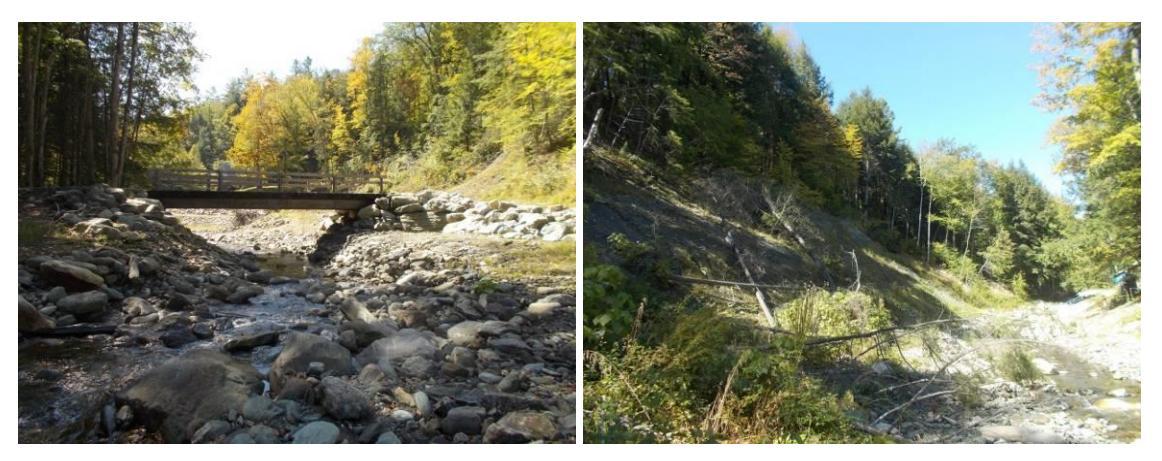
Figure 116.Left: One private bridge replaces two that washed out in T4.01A during Irene. Right: Large mass failure in T4.01A.

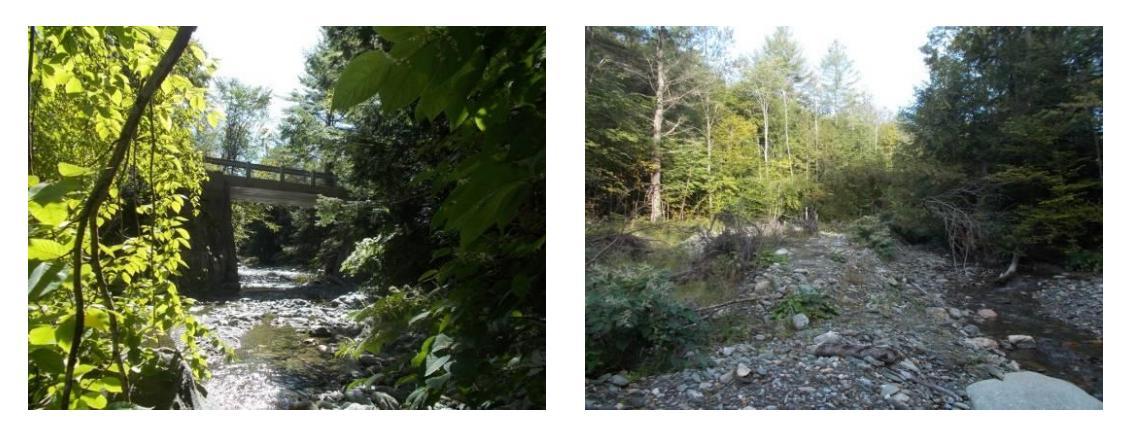
Figure 119. Left: Bridge constriction at the bottom of T4.02A. Right: Channel avulsions, where the stream jumps its banks and moves to a new location, were typical of this segment.

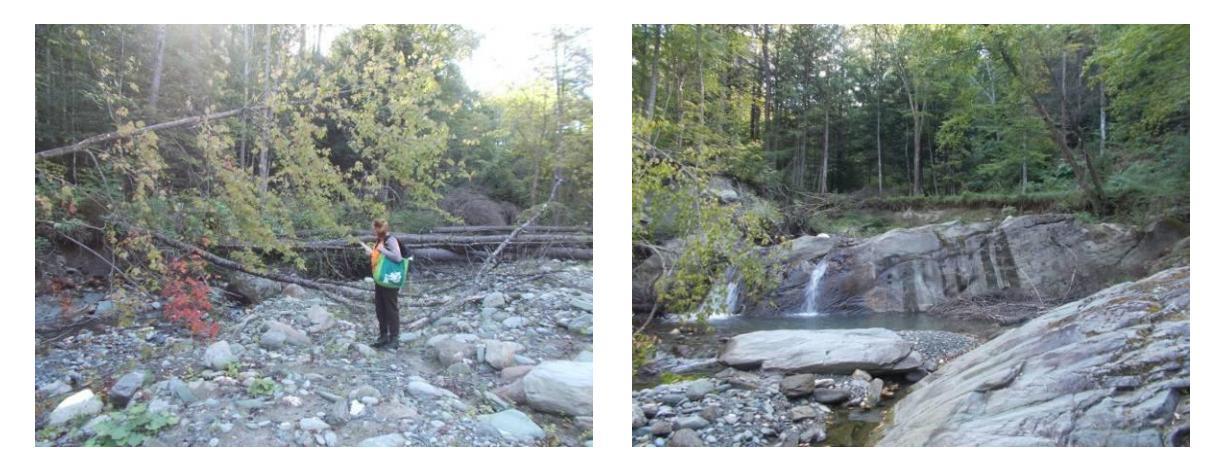
Figure 120. Left: Bank erosion is extensive in T4.02A, leading to abundant woody debris tipped into the stream channel. Right: scour and bank erosion in the area of a large bedrock grade control.

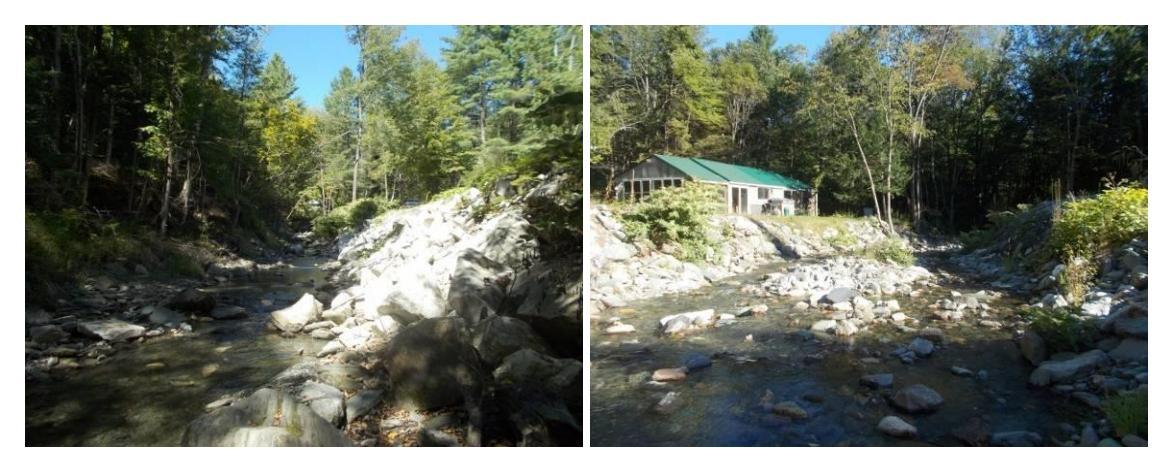
Figure 121. Left: Riprap is common in areas where the road comes close to the stream bank in segment T4.02B. Right: encroachment from buildings is not uncommon in the segment. Signs of dredging with windrowing, post-Irene, are evident in this photo.
