TWEED RIVER WATERSHED CORRIDOR PLAN

WHITE RIVER PARTNERSHIP

April 18, 2008

Prepared for:
White River Partnership and
Vermont Agency of Natural Resources/
Department of Environmental Conservation
River Management Program

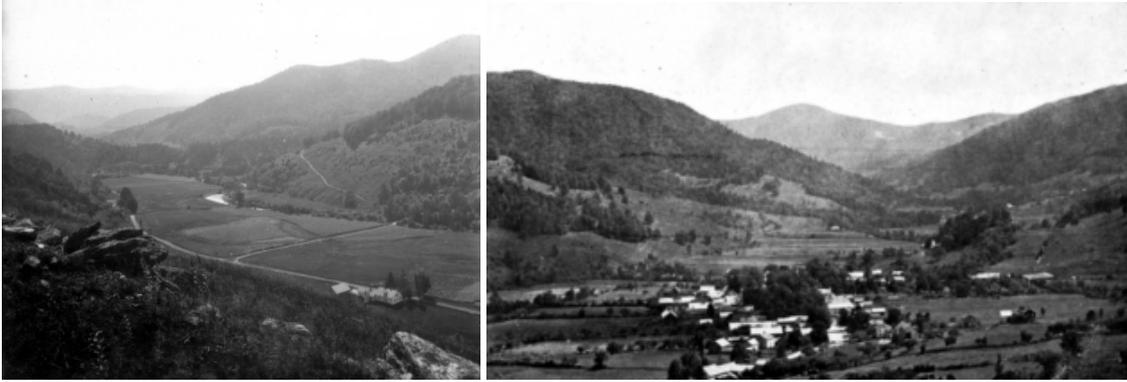
Figure 2. Pictures of the Tweed River valley from 1897 (Stockbridge looking east, left) and the early 1900s (Pittsfield looking south, right) show extensive areas of clearing in the valleys and portions of adjacent lower hillsides.
