# **Ayers Brook River Corridor Management Plan Brookfield, Braintree, and Randolph, Vermont**

June 22, 2007

## River Corridor Management Plan

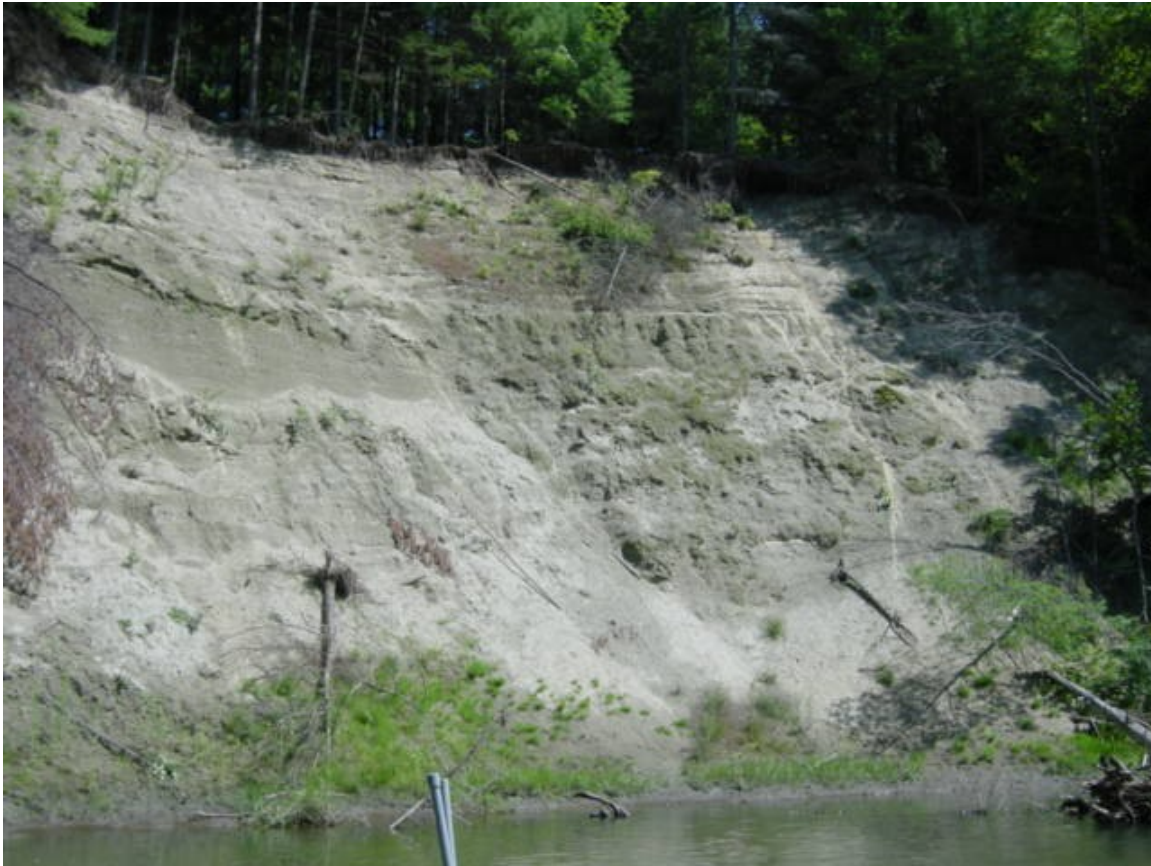
**Figure 4: Glacial lake deposits are found in the lower reaches of the study area.**

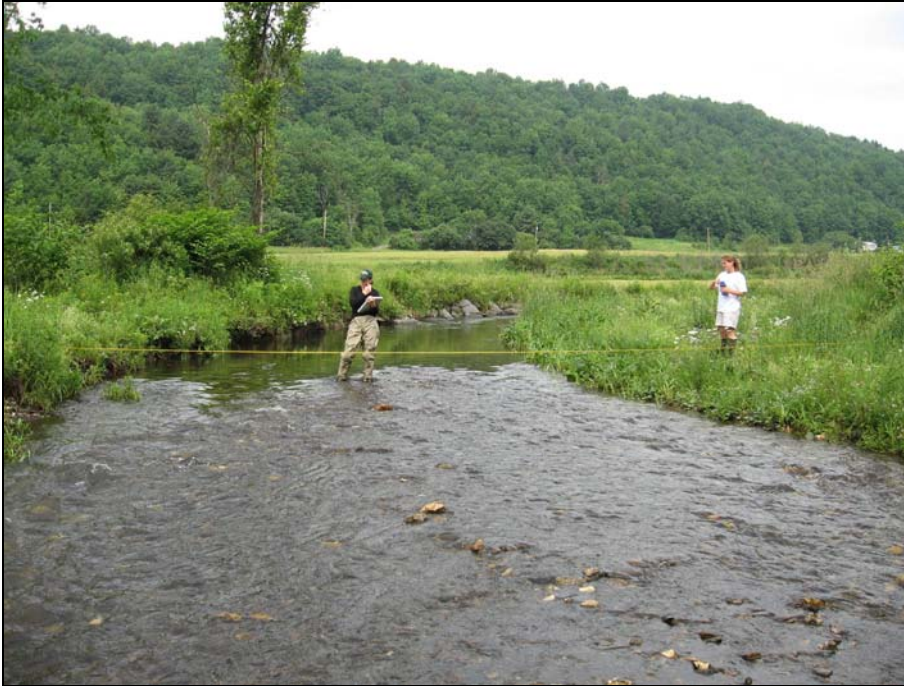
**Figure 9. Kari Dolan of the Vermont DEC and Annie Bourdon of the WRP measure the cross-sectional area of the Ayers Brook during summer 2006.**

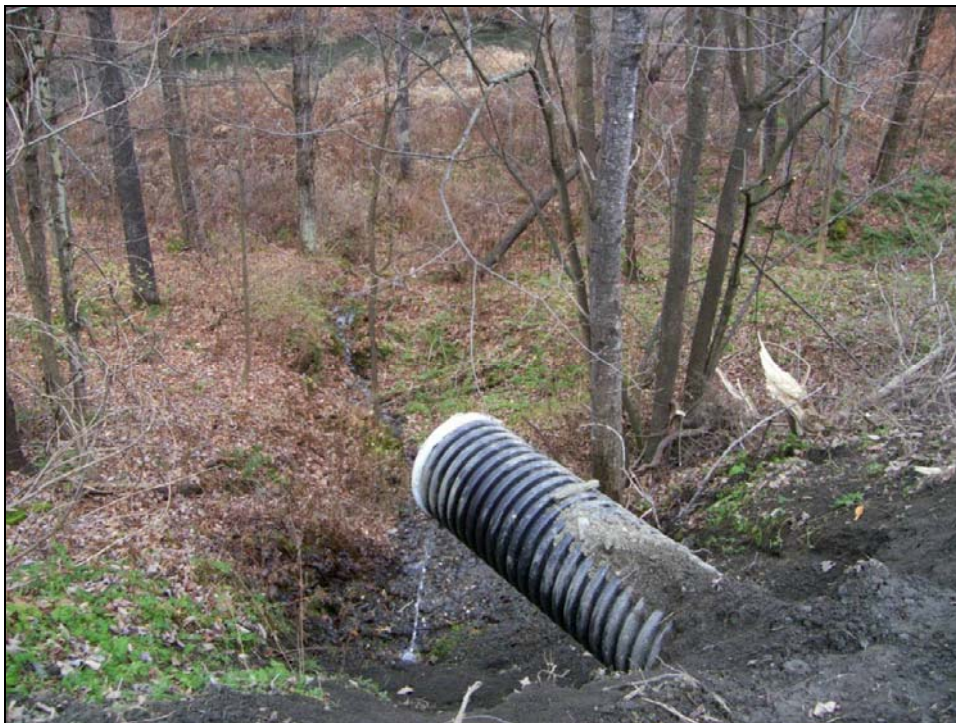
**Figure 12: Road drain emptying onto steep erodible soils off of Mason Road, T2.01-C.**

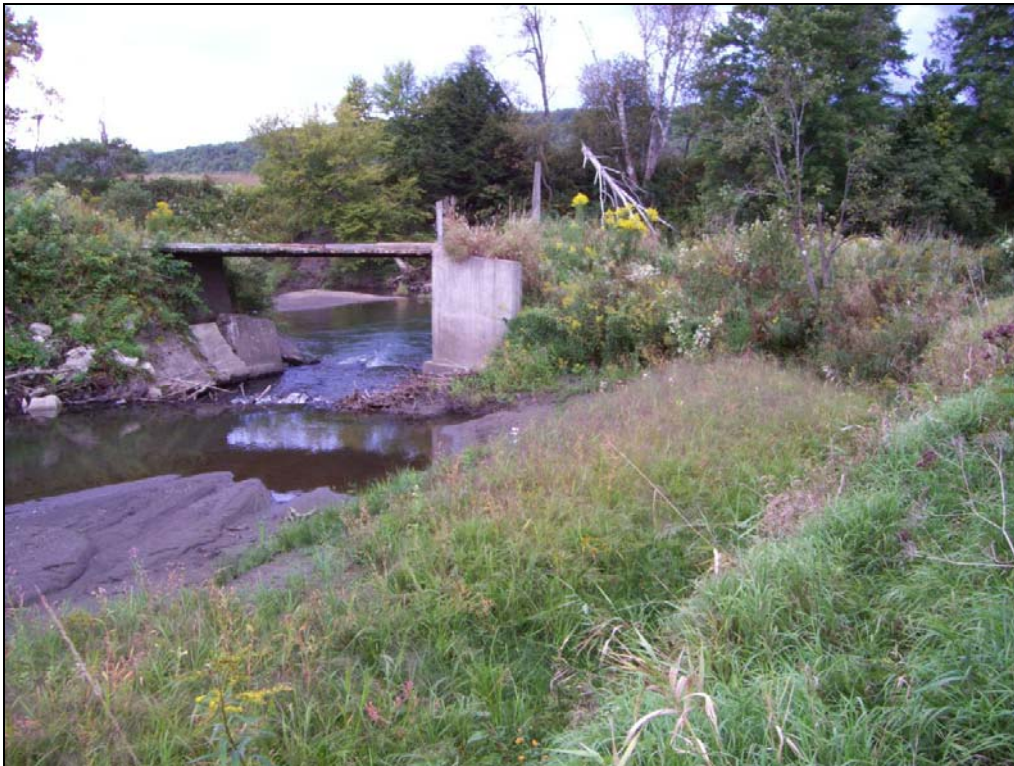
**Figure 16: Example of one of many undersized structures that are significantly disrupting sediment and water transport in Ayers Brook.**

**Undersized stream crossings** – capture sediment in unnatural patterns, may create scour downstream. The Phase 2 survey, found 12 undersized structures on the mainstem of Ayers Brook, as well as 5 old bridge abutments that were causing excessive degradation, aggradation, and/or scour in the river channel (Figure 16).
