BETHEL, VERMONT

MIDDLE WHITE RIVER AND THIRD BRANCH WATERSHEDS

STREAM GEOMORPHIC ASSESSMENT and RIVER CORRIDOR PLAN

2013-2014 December 24, 2014

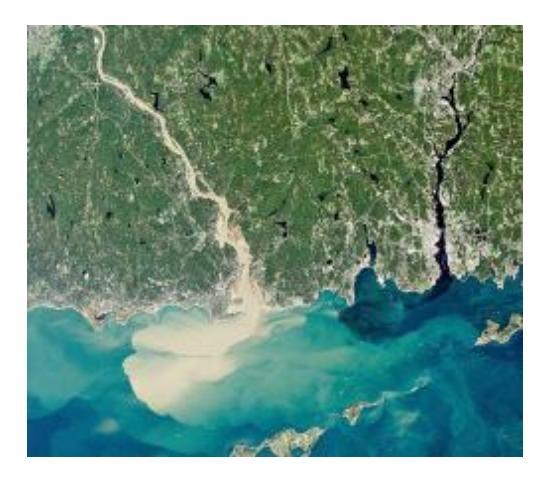
Figure 2. This sediment plume entering Long Island Sound from the mouth of the Connecticut River was evident in satellite imagery nearly a week after Irene had moved through the state of Vermont, indicating tremendous amounts of erosion and sediment export in response to the storm. (*Photo credit: NASA 2011*)

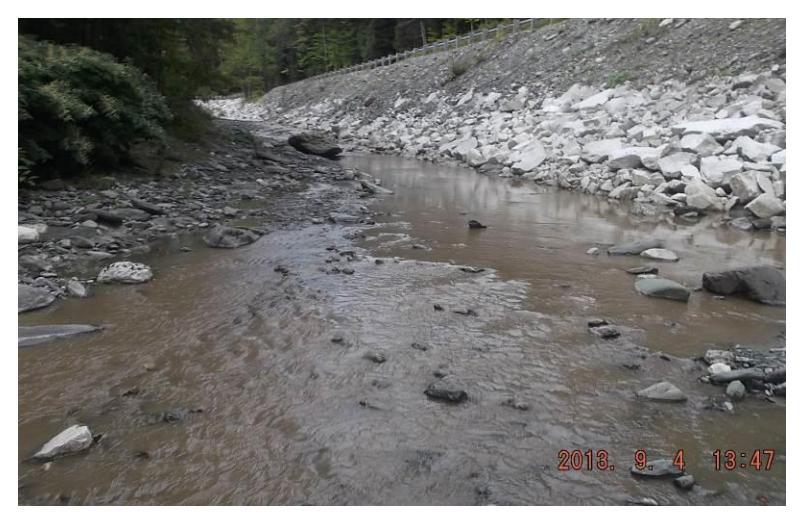
Figure 11. Although coarse sediments are common along the White mainstem and most tributaries in Bethel, fine sediments are easily transported in areas where the "bed armoring" of these cobbles and boulders has been removed from the channel as in this portion of Gilead Brook; note color of water that clouded rapidly after initiation of bridge repairs upstream.

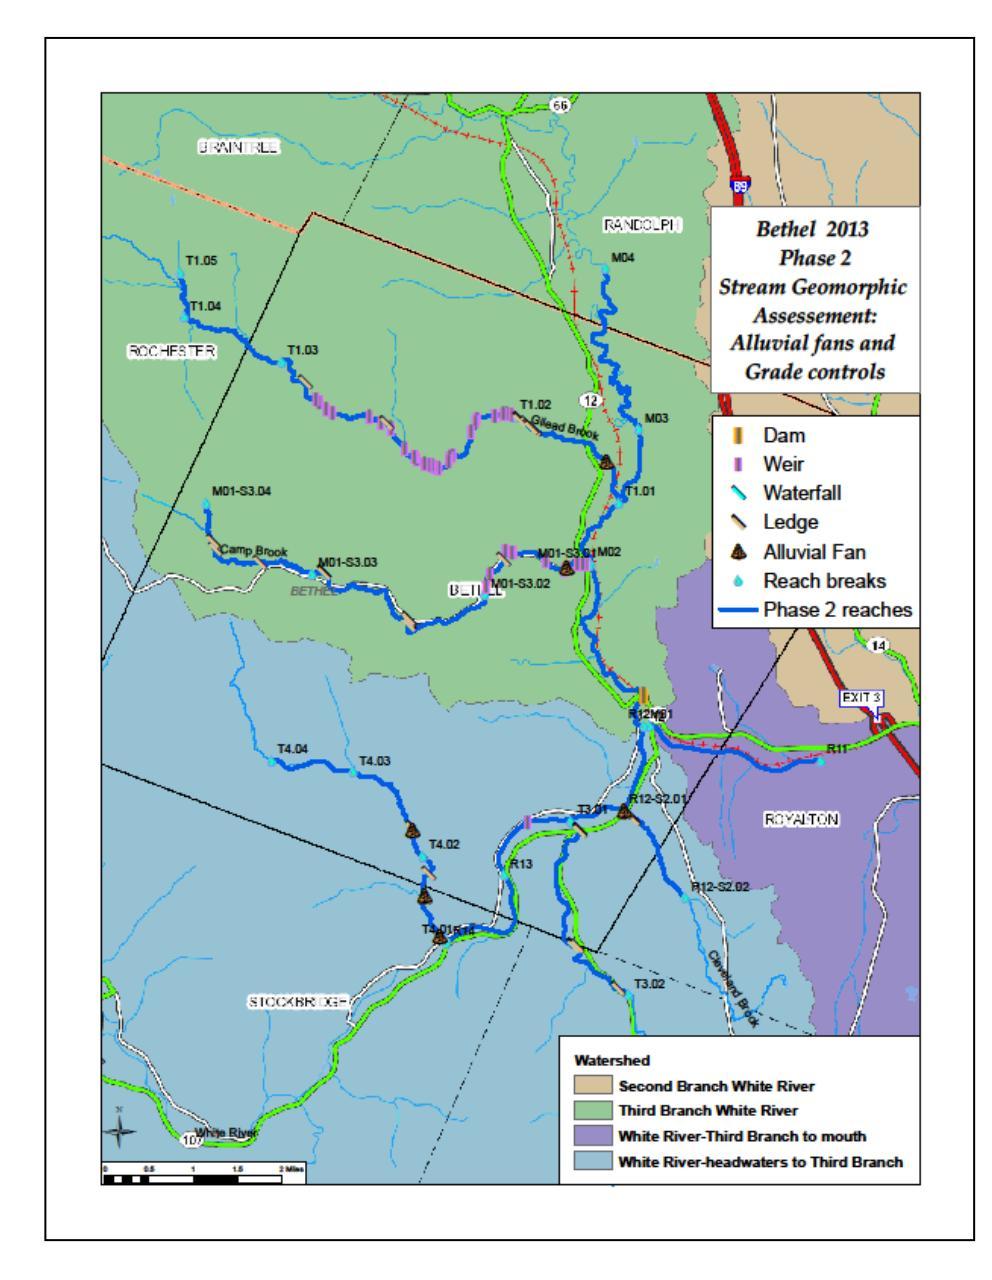
Figure 21. Natural grade controls are relatively uncommon and widely dispersed in Bethel, lending to a high degree of incision noted in most of the streams assessed in 2013 fieldwork.

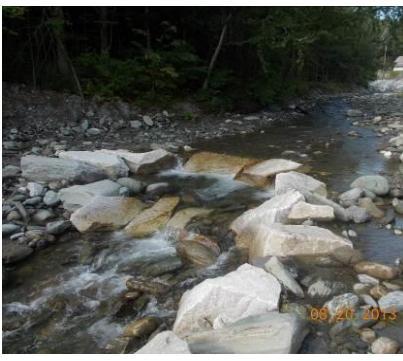
Figure 22. With few natural grade controls, portions of Camp Brook and Gilead Brook required installation of weirs to limit headcuts and downcutting in highly channelized areas post-Irene. The only weir on the White mainstem is a longstanding one at the National Fish Hatchery.

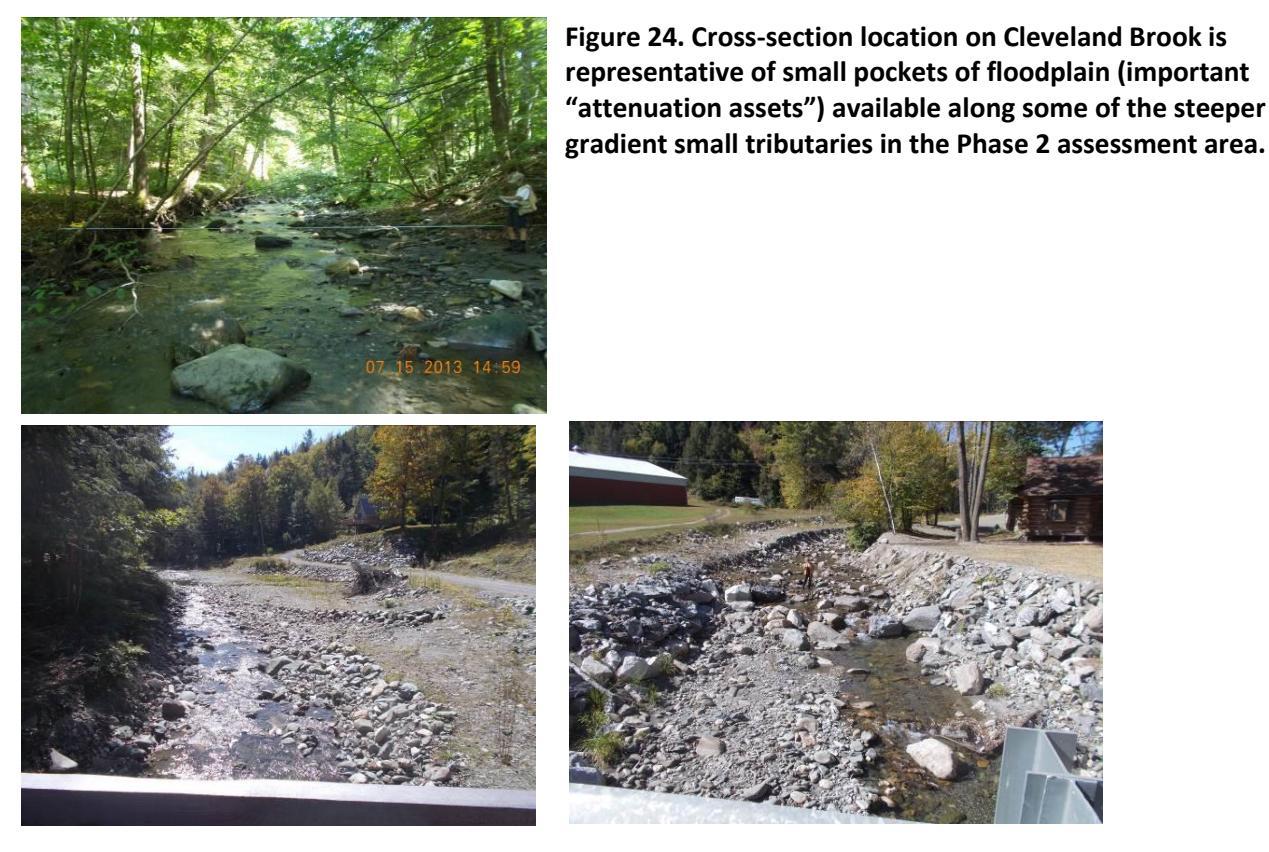
Figure 25. Similar pockets of floodplain on Lilliesville Brook occupied by development and infrastructure.

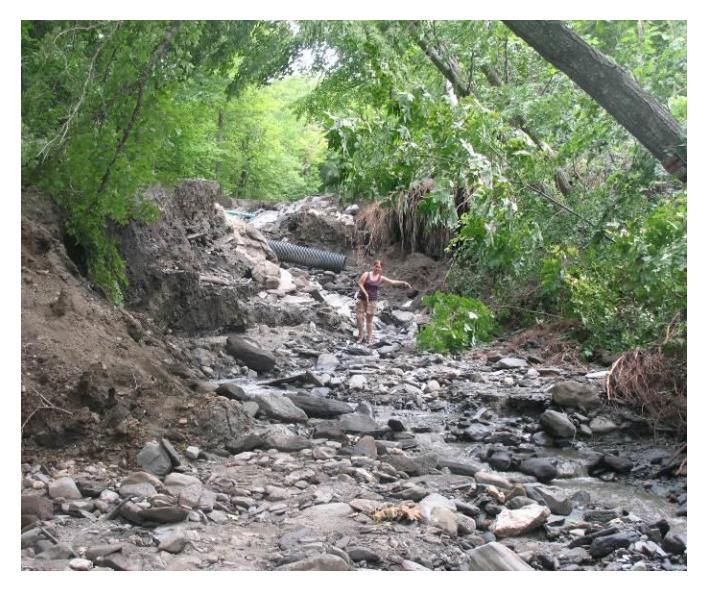
Figure 32. Damage from the July 11, 2007 flash flood on Lilliesville Brook, pictured here, was followed by similar damage in this area on August 7, 2008 when an even more localized downpour of 2+ inches of rain came along with record-setting summer rainfall in much of central Vermont.

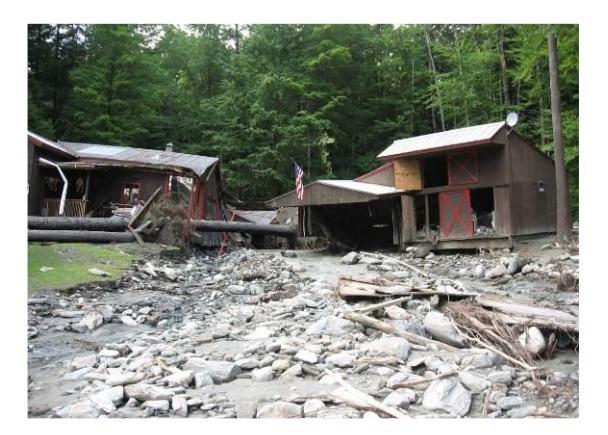
Figure 31. Flash flood damage on an unnamed tributary to Ayers Brook from July 11, 2007 storms; the woman at the center of the photo is indicating the post-storm (i.e., typical) width of the stream with her arms.

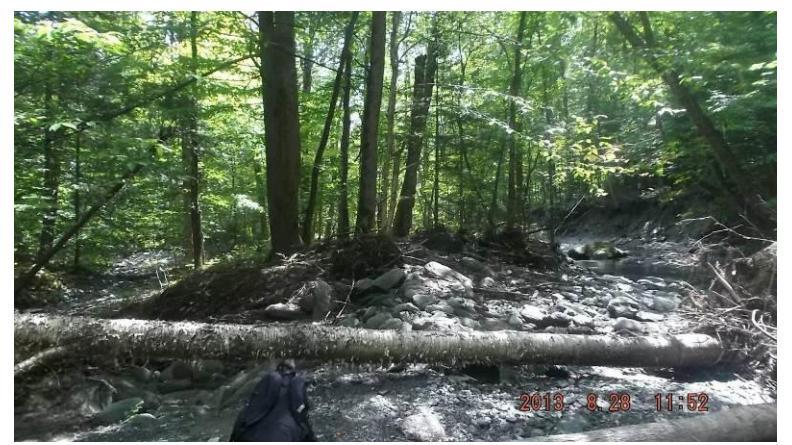
Figure 38. In narrow valleys where wood and sediment are available, a stream can actually rebuild meanders and access to floodplain; new channel in reach T1.03 on Gilead Brook (at right of photo) was several ft. higher in elevation than the old channel. Figure 39. While meandering streams typically exhibit much lower slopes than mountain trails, the meanders provide a critical function of decreasing slope (and thus energy in high flows) similar to trail

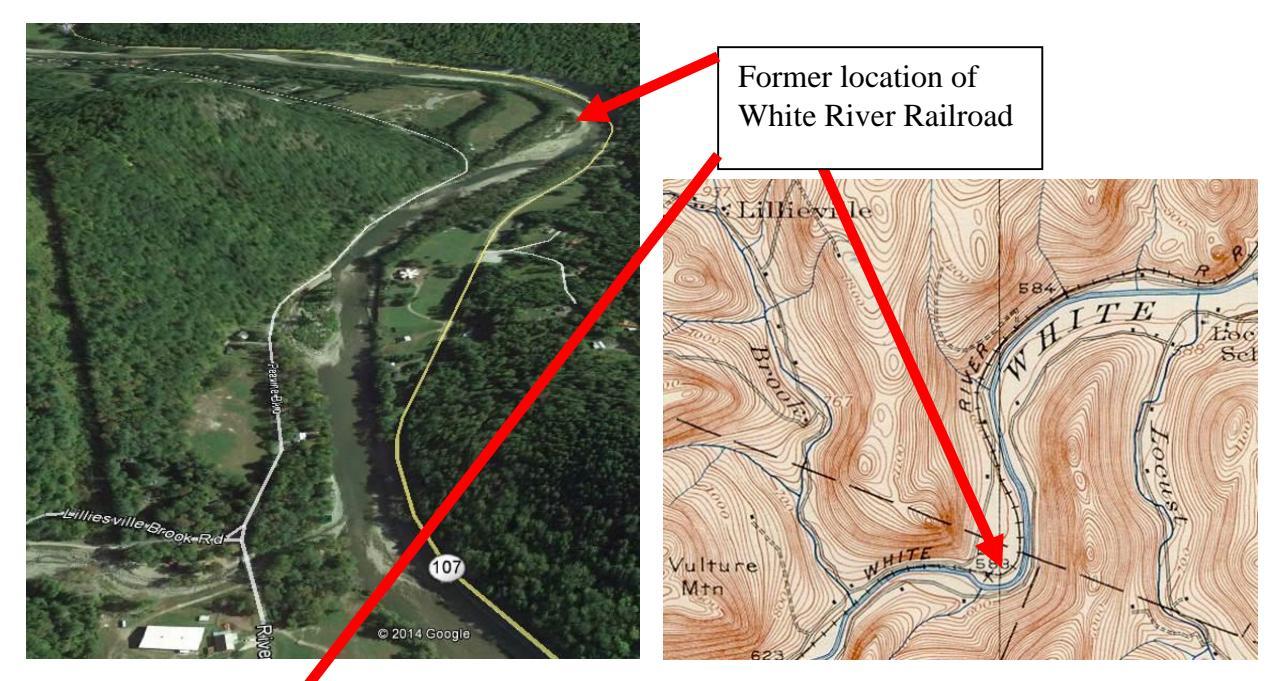
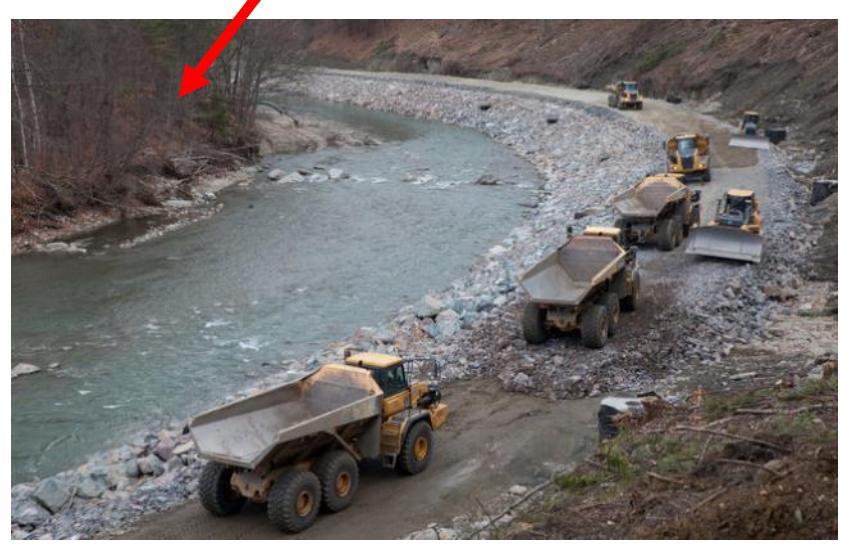
Figure 42. Although the White River Railroad (aka "the Peavine") no longer occupies the terrace downstream of the mouth of Lilliesville Brook, the portion of Rte. 107 along White mainstem reach M13 opposite this location reflects long-term impacts of straightening as a spot of recurrent conflicts between stream processes and infrastructure location. A limited amount of development and agricultural fields now occupies this terrace, which did not appear to have flooded in Irene.

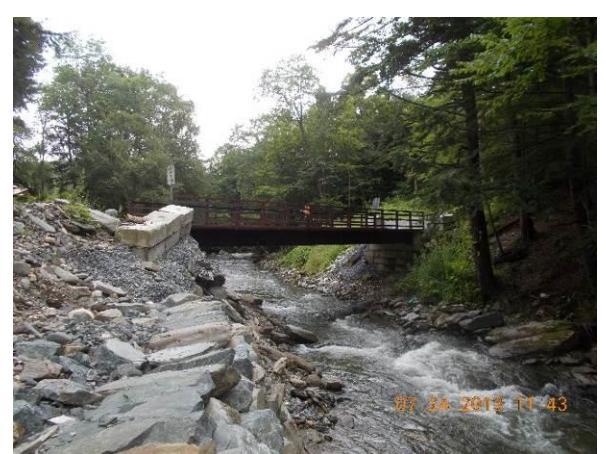
Figure 44. Increased depths in flood flows are common at undersized structures and are frequently intensified by significant bank armoring upstream and downstream of these locations.

Roughly 70% of the bridges and all of the culverts assessed in the Bethel area were sized below both floodprone and channel bankfull widths, so high level flows increase depths when being funneled through these locations. The large majority of these channel and floodprone constrictions are located on the tributaries

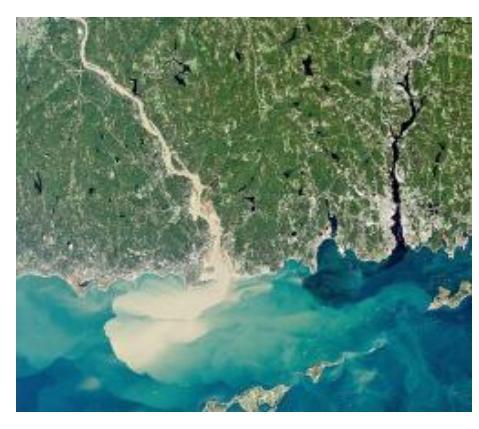
Figure 50. This sediment plume entering Long Island Sound from the mouth of the Connecticut River was evident in satellite imagery nearly a week after Irene had moved through the state of Vermont, indicating the tremendous amounts of erosion and accompanying sediment and nutrient export in response to the storm. (*Photo credit: NASA 2011*)

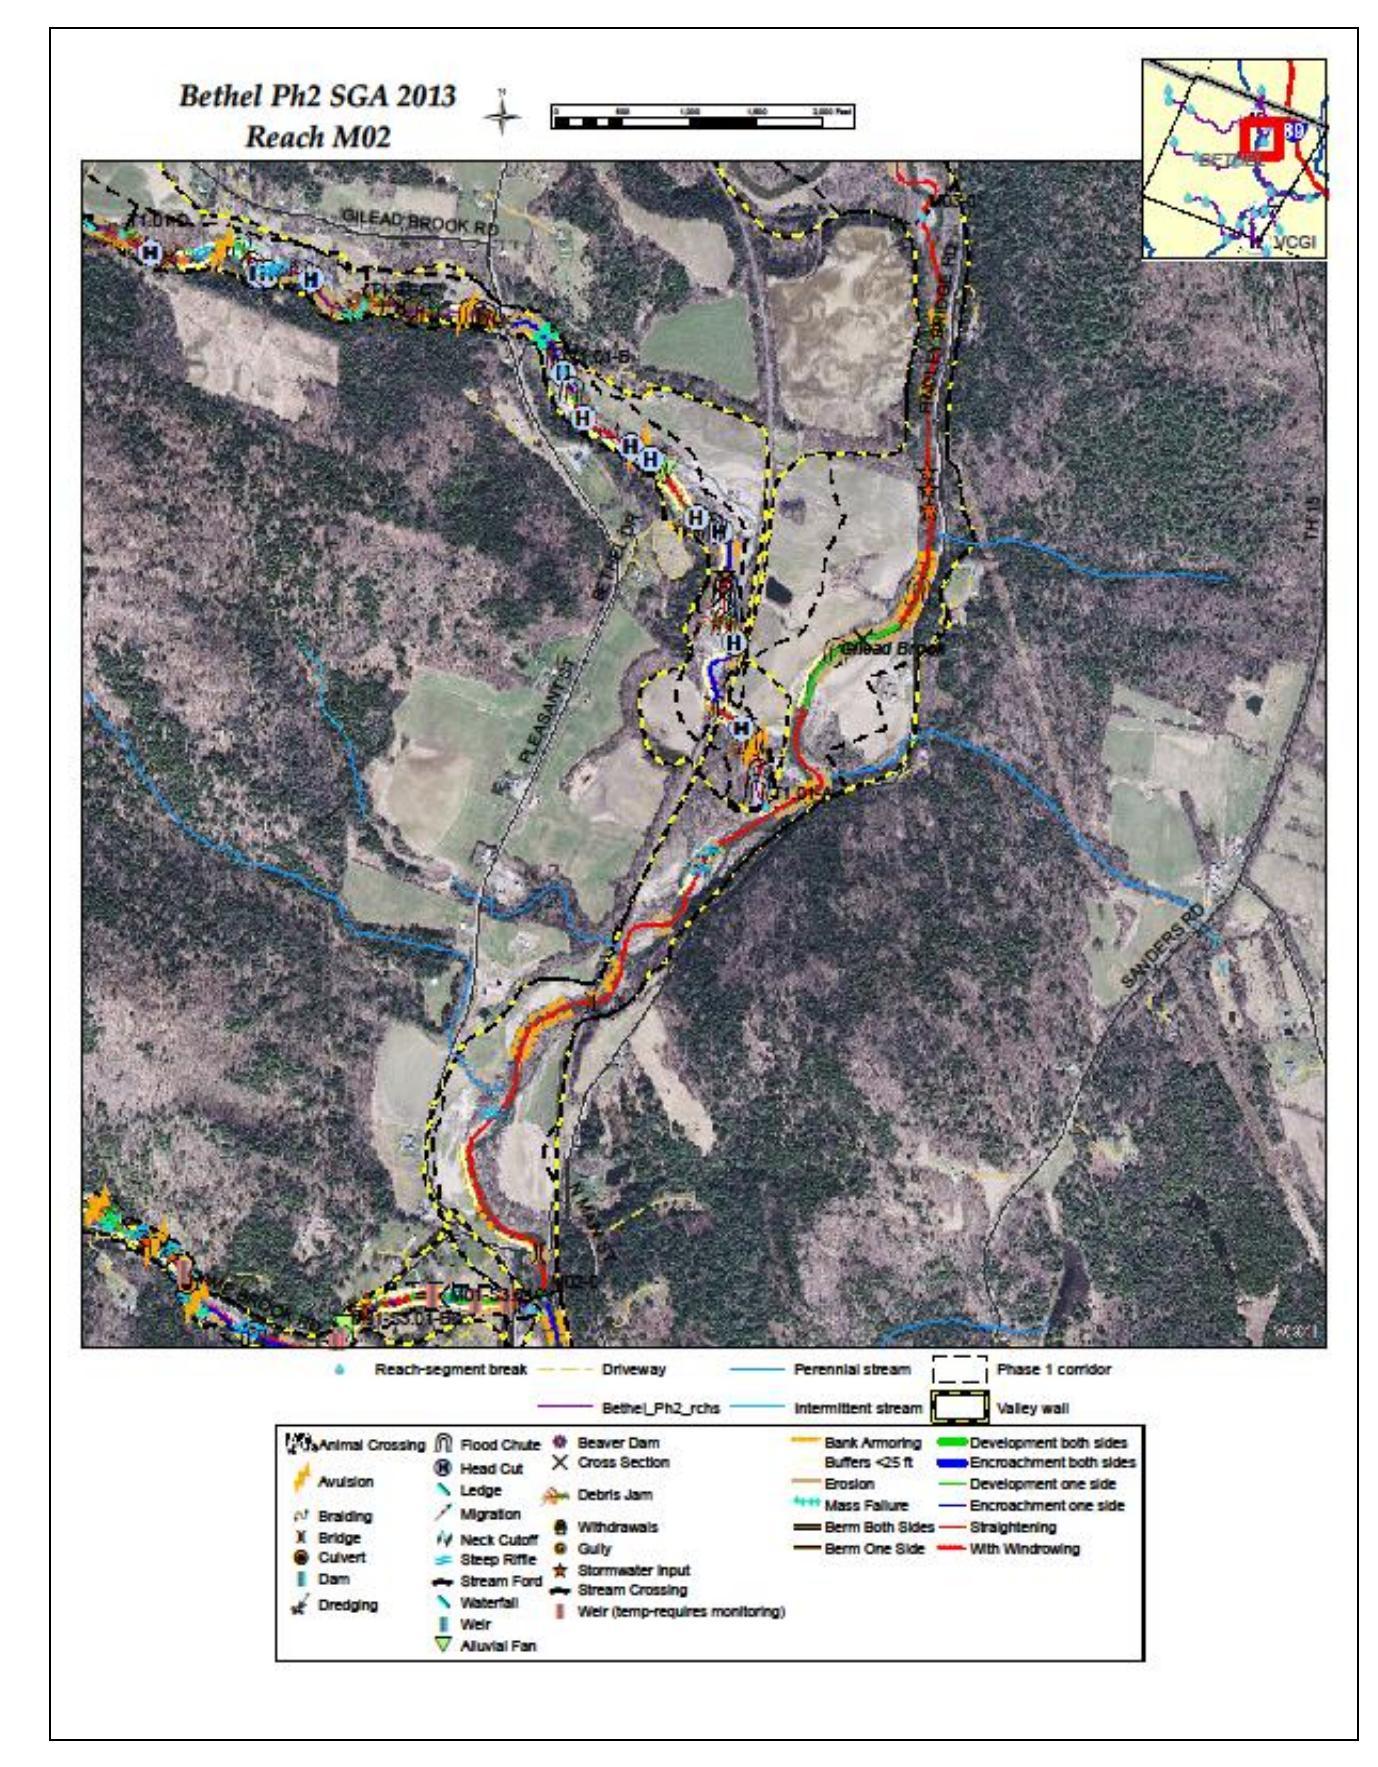
The historically shared floodplain at the confluence of the Third Branch and Gilead Brook is one of several alluvial fans in reach M02 that were likely deltaic formations deriving from tributaries at the edges of glacial Lake Hitchcock, contributing to the presence of very fine (and highly erodible) soil materials (fluvial sands, pebbly sands, and lake gravel) along much of the reach. The fine sediments present along the stream channel extend into the terraces along both banks, and the reach is primarily dominated by cropland use that is more extensive along the right bank due to the maintenance of the stream along the left valley wall.

Steep riffles composed of large deposits of these fines evidenced steep faces on their downstream ends, tapering into deep scour pools carved into the highly erodible bed by the high flows of Tropical Storm Irene. Despite the presence of bedrock outcrops on the banks along portions of M02, there were no channel-spanning grade controls in the reach and the high degree of straightening contributes to long stretches of relatively deep runs with only one relatively stable riffle noted in the reach (as opposed to sediment slugs composed of highly unstable fines).

Figure 56. Bethel M02 reach map - Third Branch mainstem.
Primary Stressors:

- Straightening (>50% of segment length) primarily by virtue of encroachments by railroad, effects of two bridges, bank armoring and maintenance against left valley wall
- Extremely erodible banks (sand), right bank buffers lacking
- Loss of access to historic floodplains (incision ratio 2.0)
- Stormwater inputs (2 road ditches, 2 field ditches)

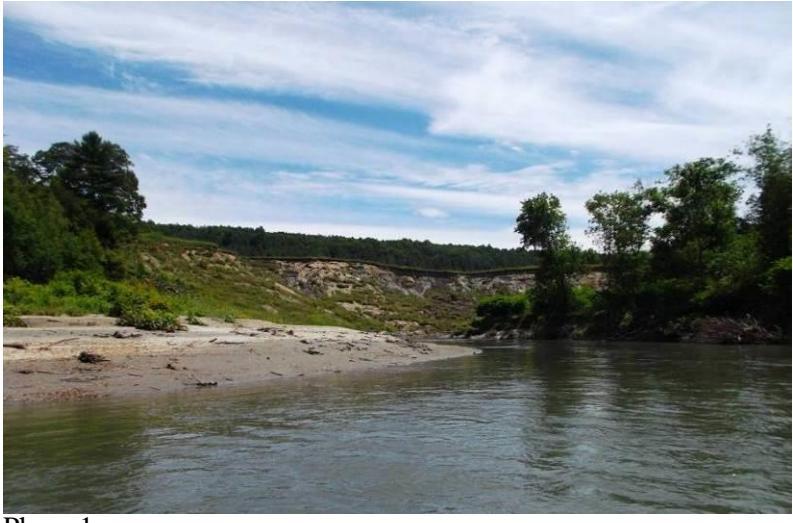
Figure 57. Third Branch reach M03 near the Bethel –Randolph town line had several mass failures where the highly erodible valley walls had fallen away for stretches exceeding hundreds of ft. in length and 40-60 ft. in height.

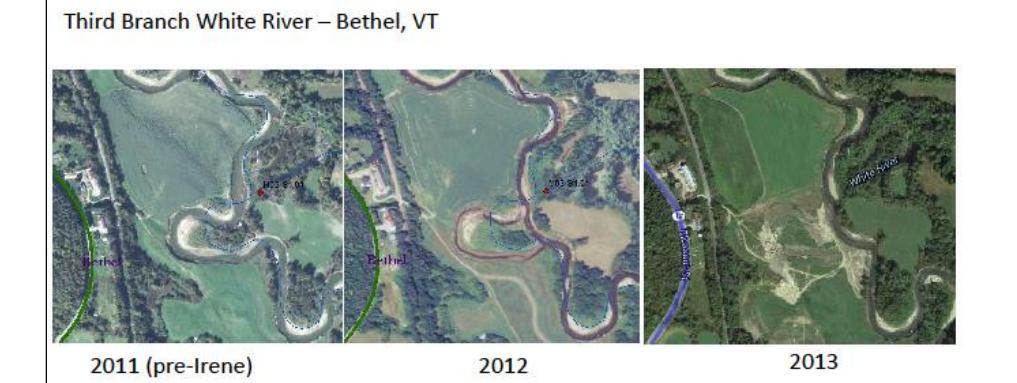
The large numbers of mass failures and stretches of relatively intact floodplain forest along this reach have contributed a fair degree of large woody debris to the stream, but full debris jams were uncommon due to the size of the channel in comparison with the relatively small trees present along the banks. There were numerous partial debris jams contributing to sediment retention and formation of alternating depositional features and scour pools. The reach thus appears to have a relatively high capacity to re-establish a more stable planform in terms of slope (through formation of new meanders), but lack of grade controls predisposes the bed to further downcutting that can exacerbate the current lack of access to historic floodplains. The lack of full debris jams indicates the stream is limited in its capacity to actually rebuild access to abandoned floodplains (though channels sometimes end up at a higher elevation after an avulsion routes the stream to a new location), and further channel evolution is likely to continue to manifest as rapid widening, channel avulsions and neck cut-offs in response to high flows contained within the

Figure 59. Neck cutoff along the Third Branch before and after Tropical Storm Irene.

These dynamics place a high value on minimizing stream encroachments throughout a wide corridor and retaining, protecting and restoring wide stream buffers that can further mature along reach M03. Bank armoring observed along the reach is likely to be temporary due to the highly dynamic nature of the stream in this area (Fig. 60), and limiting further installations (this may require compensation for foregoing current agricultural land use in some areas) is highly recommended as a means to reduce further erosion and mass failures downstream as well as allowing the stream to establish a wider floodplain at a lower elevation.

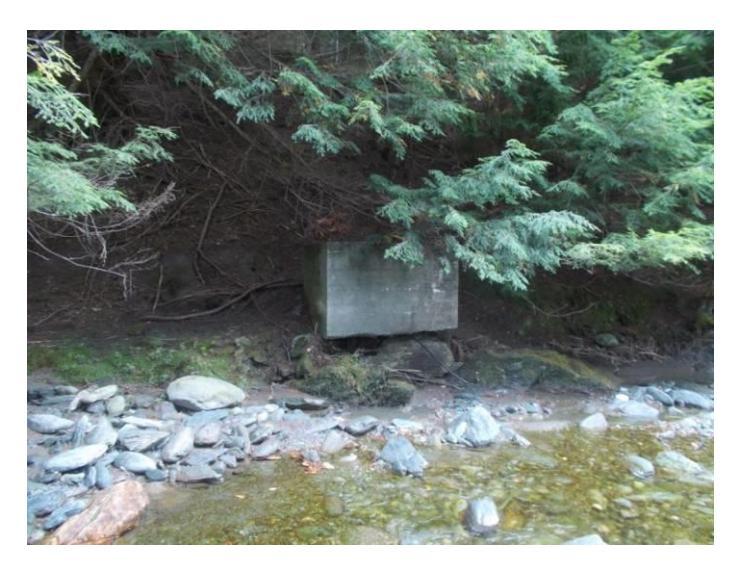
as a whole, and likely explain why segment B has retained more floodplain access than other parts of Camp Brook (and is not so incised as to cause a reclassification of the stream type). There are multiple terraces in evidence that do indicate a history of incision, however, and an exposed spring box that apparently was once sitting in the stream channel gives a good indication that recent incision was experienced in portions of the segment where bedrock grade controls were not limiting downcutting (Fig. 69).

Figure 69. This exposed spring-box was reportedly sitting on the stream channel bottom in the recent past, previous to bed incision (downcutting) in Irene and other high flows.

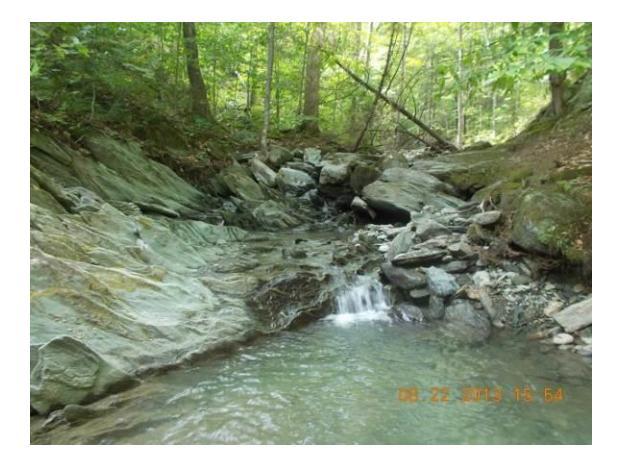
Bedrock grade controls provide some stability to the stream bed in M01S3.03B and arrest incision immediately upstream (Fig. 73). The incision level for this segment is lower than for Segments A and C, largely due to the presence of bedrock in the channel.

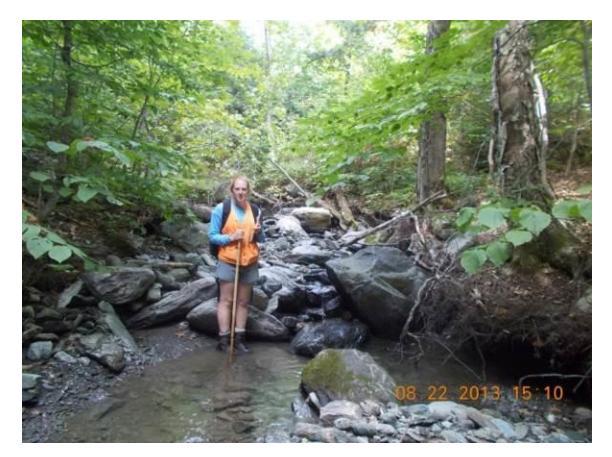
M01S3.03C is high in the watershed and somewhat buffered from storm flows by having impounded wetlands upstream (although these same wetlands can contribute significant amounts of water when beaver dams burst or a saturation point is otherwise exceeded). The channel is significantly narrower in width than downstream segments, but despite its smaller size there was still extensive evidence of recent bank erosion and incision in the segment. Human disturbance is minimal in M01S3.03C, and although there is evidence of past harvesting in the area there were no signs of recent activity. Recent impacts here appeared to be largely due to the failure of upstream beaver dams, and high degrees of incision noted in this segment likely also reflect downcutting through fine sediments formerly deposited behind historic beaver dams (Fig. 74).

Figure 74. High incision ratio noted in M01S3.03C maybe be due to a combination of failure of upstream beaver dams and downcutting through fine sediments accumulated during historic times of impoundment within the segment.

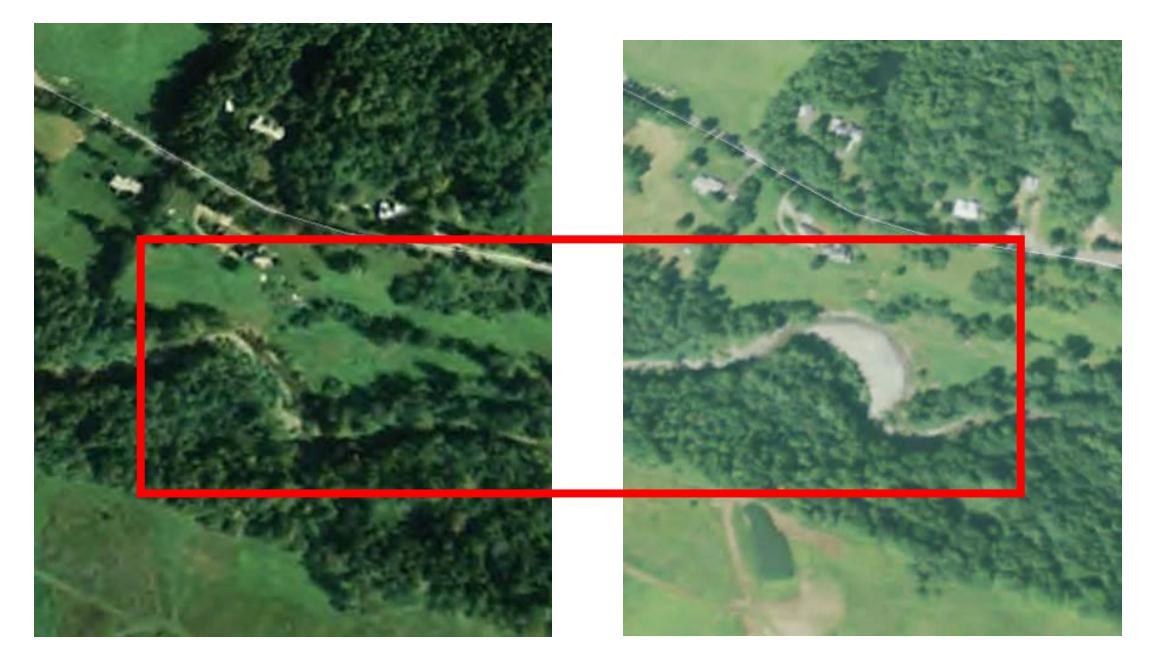
Figure 78. Google Earth historical imagery (left, 2006; right, 2008) indicates a channel avulsion in segment T1.01C (near 379 and 322 Gilead Brook Rd.) likely occurred in July 2007 flash flooding.

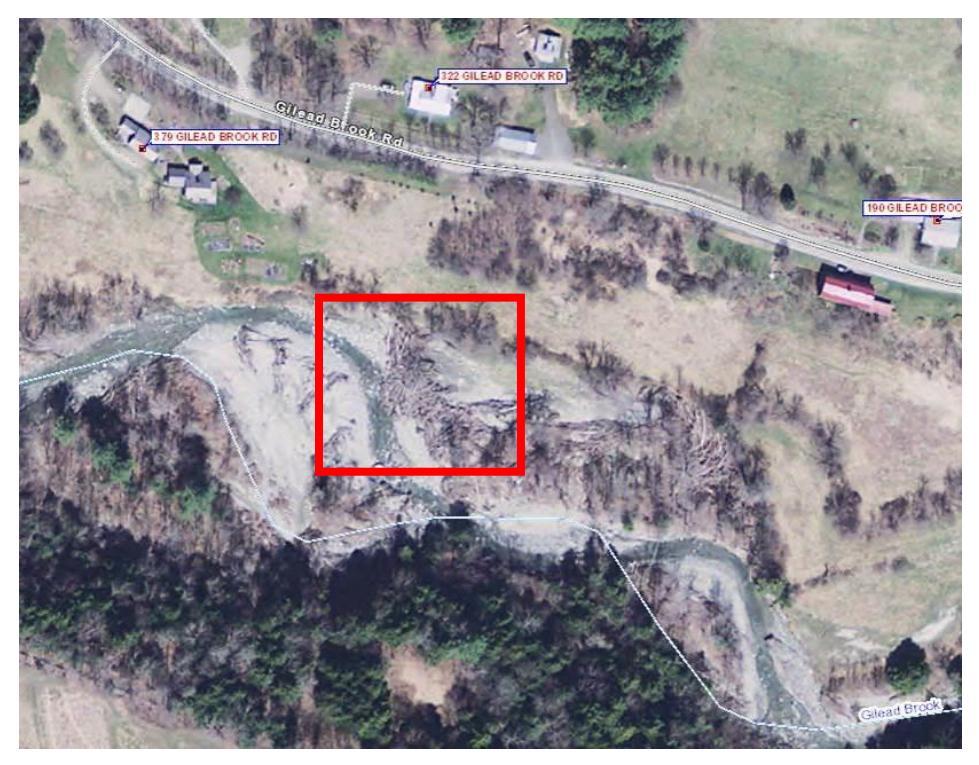
create any real berms that would restrict floodplain access, although one large pile of trees and other large woody debris (deposited by Irene, augmented with wood snagged from the stream) restricts floodplain access off the left bank across the road from 322 Gilead Brook Road. Historical aerial imagery in this area indicates a channel avulsion in the vicinity of this wood pile (visible in 2008 Google Earth historical imagery) likely occurred in July 2007 flooding (NOAA-BTV 2007; Figs. 78 and 79).

Figure 79. Wood deposited by Irene (this aerial imagery is May 2012) and augmented with wood snagged from the stream now restricts access to left bank floodplain, hindering an important mechanism for enhancing stream stability and diffusing stream power in flood flows. These stream dynamics in T1.01C indicate that the lack of development constraints here represents an important asset for stream stability, as does a small pocket of young floodplain forest on the left bank just upstream of this area. This floodplain forest was quickly being colonized by Japanese knotweed that appeared to have been washed into the area and may have been introduced in the July 2007 flash flooding. Knotweed typically does not flourish as well under a canopy as in the open, but the large opening created by the channel avulsion just downstream and scoured by subsequent flooding in Irene is highly susceptible to having regeneration of native woody vegetation negatively impacted if knotweed becomes well established.

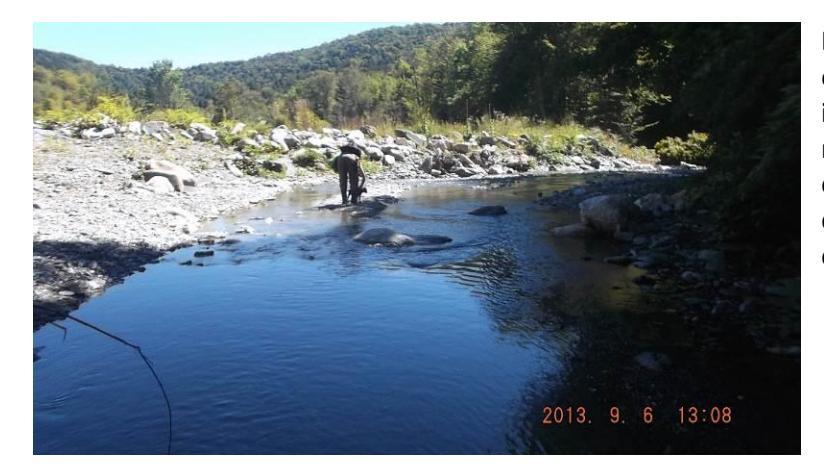
Figure 81. Potential for further bed erosion in response to channelization in segment T1.02A is indicated by a nickpoint (inverted V-shape flow at center right of photo) forming at the dislodged stone in the center of this constructed weir.

Constructed steps/weirs were placed to arrest headcuts in response to channelization in other spots along this segment as well, and one had a central stone dislodged enough to allow a nickpoint to start forming at the time of 2013 field assessment. Follow-up monitoring of these weirs (and repair if necessary) will be important to maintaining or rebuilding access to floodplains that will play a large role in ensuring better long-term stream stability and flood resilience along Gilead Brook, especially by dissipating the force of otherwise channelized and restricted flood flows. Several opportunities also exist in this segment to restore floodplain behind the windrow; a windrow off the left bank just upstream of the cross-section measured for this segment during Phase 2 was fairly representative (Fig. 82). In addition, a high berm situated in the woods just west of 2577 Gilead Brook Rd. cuts off access to left bank floodplain downstream; although removal would gain significant floodplain access it would also likely pose risk to a shed 100 ft. downstream of the berm.

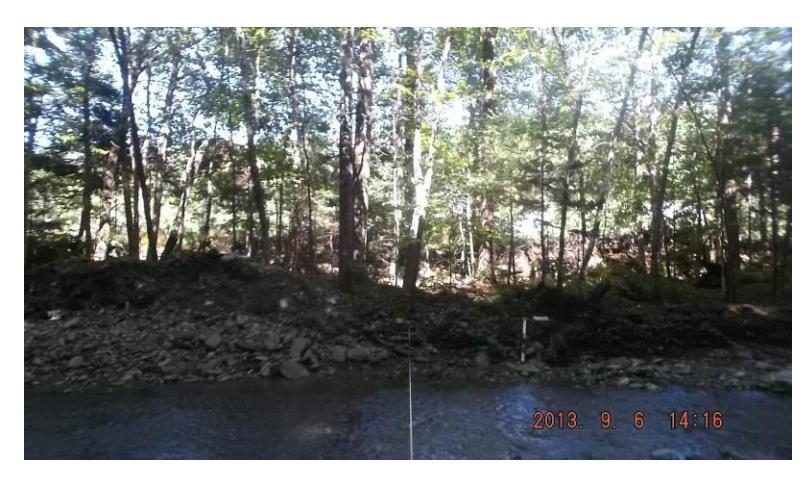
Figure 82. Windrow just upstream of the segment T1.02B cross-section (left of photo) is 1-2 ft. higher than the floodplain behind the windrow and is representative of several opportunities in this segment to restore floodplain access (without apparent impact to nearby structures or infrastructure) by cuffing off the top of the windrow.

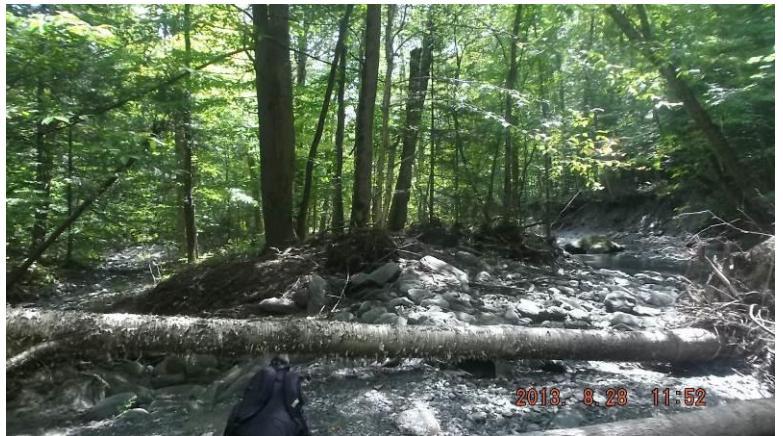
Irene cut a new channel through the mid-portion of reach T1.03 that is roughly five ft. higher in elevation than the old channel. It appeared that this is likely a characteristic dynamic in this reach: debris jams and sediment plugs lead to channel avulsions and relocations, with significant and rapid shifts in the channel location over time followed by stabilization and re-vegetation in a new location before the channel jumps to a new location (Fig. 83).

Figure 83. A debris jam and sediment plug in reach T1.03 led to a channel avulsion that left the current channel (right in photo) at a higher elevation than the former channel (left in photo). This wood and sediment provide channel roughness and rebuilt access to abandoned floodplain, critical to diffusing stream power and re-establishing stream stability.

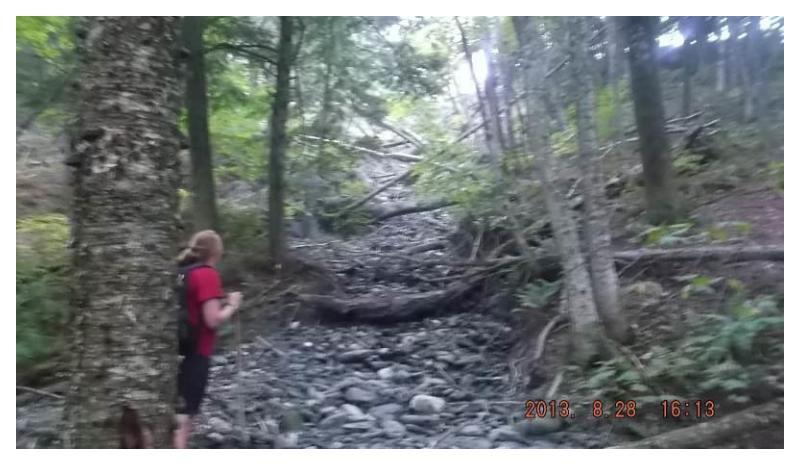
A Class 4 (i.e., not town-maintained on a regular basis) section of Gilead Brook Rd. that runs high on the southern valley wall of reach T1.03 (to Rochester Little Hollow), with numerous crossings of tributaries to this reach, appears to be a popular 'mudding' road and a number of the stream crossings are gullied. Gullies along tributaries and stormwater inputs on the extremely steep valley walls of this reach were common in Irene (and would be extremely difficult to repair at this point), and it appears beaver dams upstream may have breached and contributed to a storm surge in this reach as well. All of these inputs were contributing significant sediment deposits and large woody debris that are likely to contribute to stabilizing these areas over time, but the net effect is a significant extension of the stream network (rather than diffuse flows over a wider surface) that will contribute to more concentrated and rapid delivery of water to Gilead Brook in future downpours especially (Fig. 85).

Figure 85. Large woody debris and coarse sediments visible in this gully emanating from a field ditch on top of the T1.03 valley wall are beginning to help stabilize this slope, but the gully now effectively extends the stream network (rather than having sheet flows over broader portions of the slope) in heavy downpours.

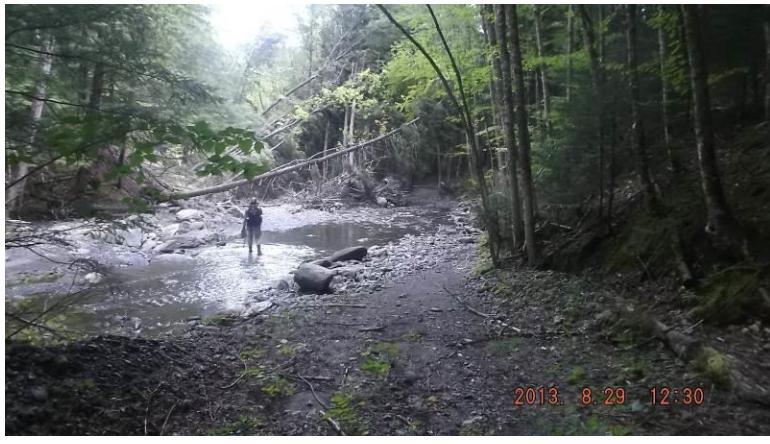
There were no signs of dredging in reach T1.03 but wood was snagged in a couple areas with the apparent intention of preventing the stream from accessing woods roads and trails as flood chutes. Low lying sections of woods roads in a couple locations were erased by the stream in Irene, technically making these areas fords now (Fig. 86); location of these sections further upslope would be challenging but access to substantial portions of the woodlot may be limited without these sections of road.

Figure 86. Portion of a woods road reclaimed in part by Gilead Brook reach T1.03 during Irene now makes this effectively a ford rather than a road.

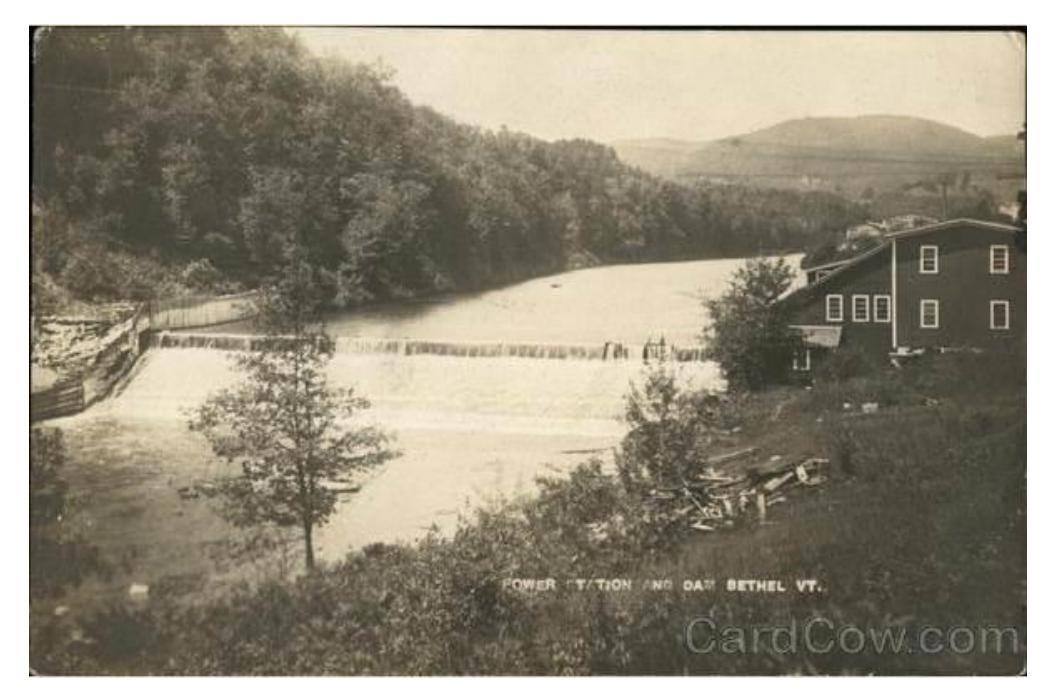
Incision is long-standing in reach R11 and likely the combined result of glacial processes eroding through pebbly sands at the edges of glacial Lake Hitchcock as well as pulse flows and "hungry water" dynamics (see discussion in Ch. 5.1.1, Hydrologic Regime stressors, of this report) related to flow regimes at the former dam site off the end of Power Dam Road (Fig. 89).

Figure 89. Former power dam on the White River mainstem in reach R11 near the Bethel-Royalton town line.

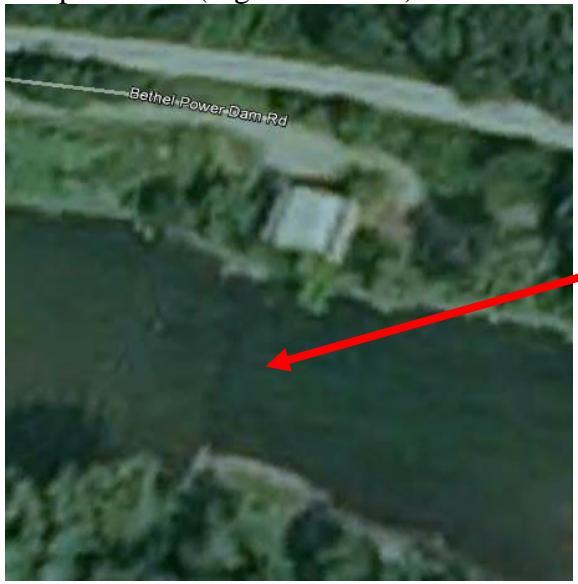
Heightened stream power flowing through this semi-confined valley during Irene was evidenced by a strikingly deep scour pool at the old dam site and the apparent removal of much of the former cribbing that had been still evident at that site; the difference is visible in imagery preand post-Irene (Figs. 90 and 91).

Figure 90. Google Earth imagery from 2009 shows channel-spanning cribbing from the former Power Dam on the White River mainstem near the Bethel-Royalton town line.

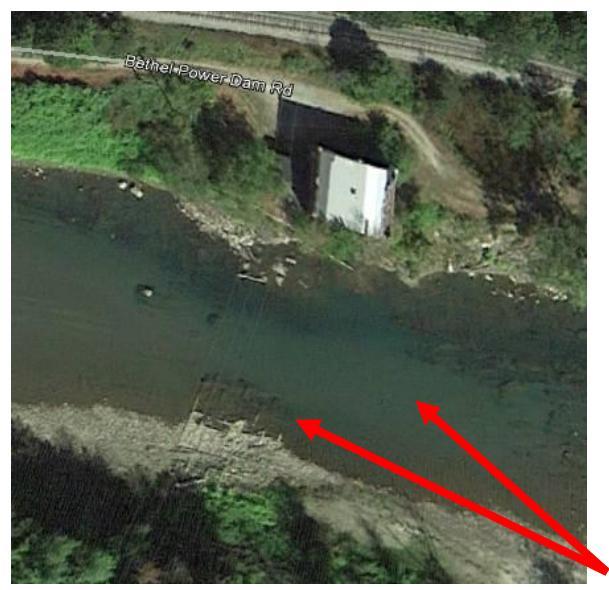
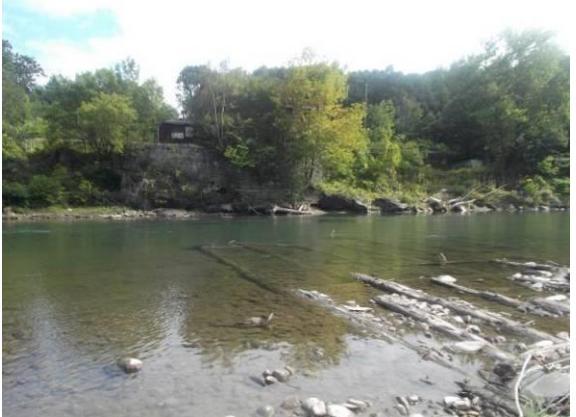
Figure 91. Imagery from 2013 shows a large portion of the mid-channel cribbing gone and replaced by a scour pool.

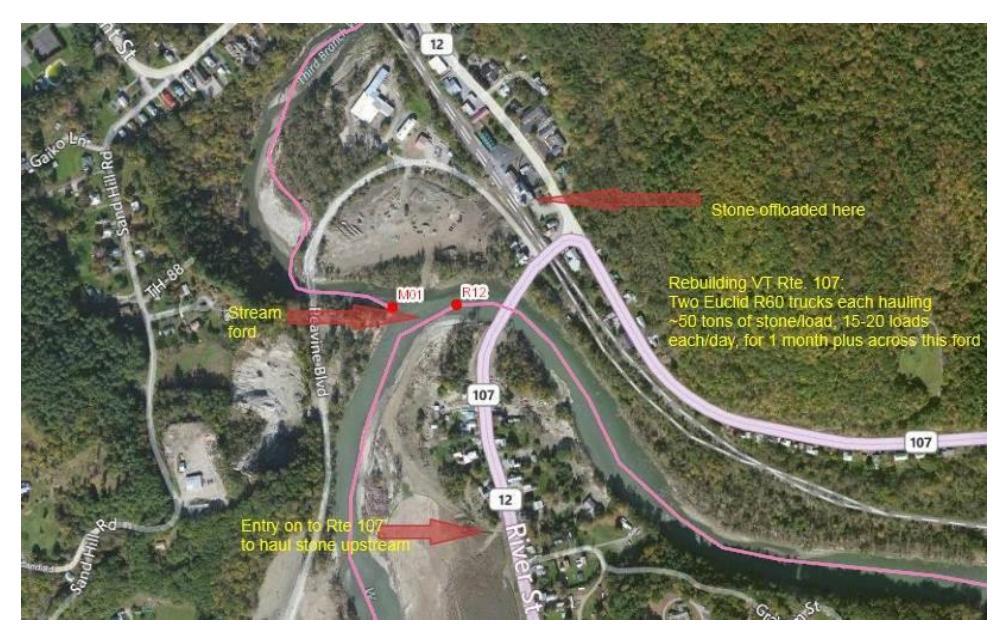
Irene contributed to bed feature formation in numerous areas along reach R12, creating more defined riffles, point bars and scour pools, but material was removed from the channel following Irene as well and long stretches of sedimented featureless plane bed and the current degree of entrenchment leave this reach in a continuing state of evolution. Heavy equipment instream work was extensive in this reach and reach R13 upstream post-Irene, with the New England Central Railroad line at the confluence of the Third Branch and White mainstem in Bethel village (the reach break at the downstream end of reach R12) used as a staging area to bring in and load stone onto large trucks that forded the White at this confluence enroute to the most heavily damaged portions of Rte. 107 upstream (Fig. 93; hizzy19 2011).

Figure 93. Stream ford at the R12 reach break was used to haul stone offloaded from the rail line in Bethel village across the White River and upstream to the most damaged portions of VT Rte. 107.

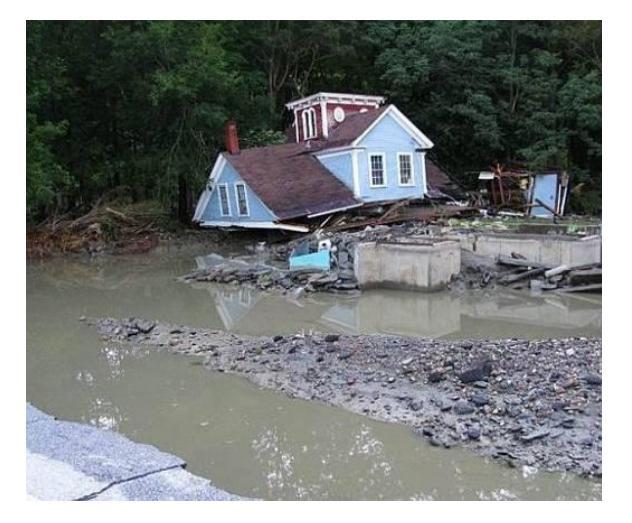
contributed to significant damages including several houses (Fig. 95) and the River Street (Rte. 107/Rte. 12) Bridge, which required replacement with a temporary bridge while the damaged bridge was replaced.

Figure 95. Houses damaged in Bethel during Irene in the vicinity of the River St. bridge at the downstream end of reach R12. *Photo credits: Ann Froschauer/US Fish & Wildlife Service*

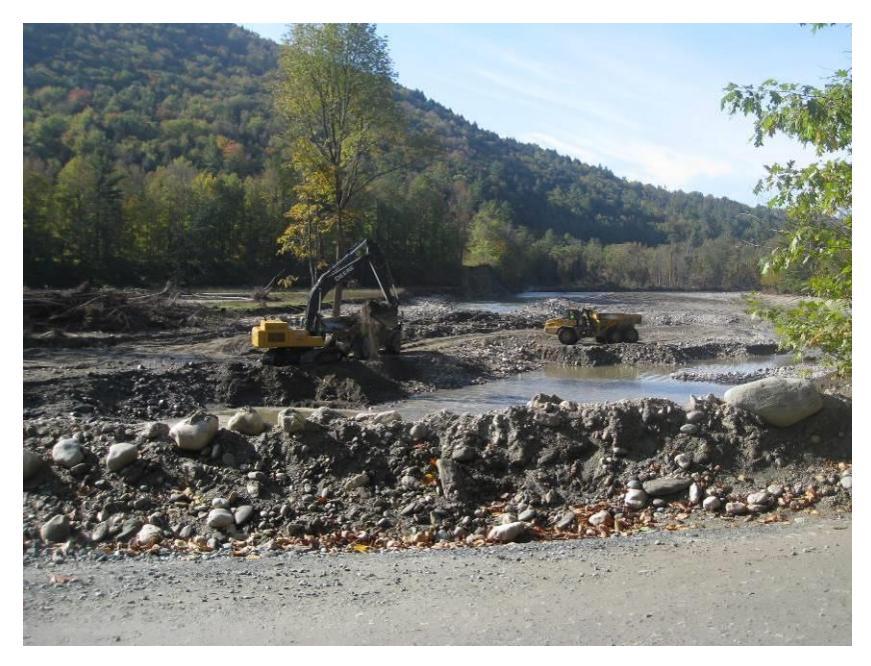
Figure 98. Dredging the White mainstem for material to rebuild Rte. 107 along reach R13. *Photo credit: Adam Smith*
