BETHEL, VERMONT

MIDDLE WHITE RIVER AND THIRD BRANCH WATERSHEDS

STREAM GEOMORPHIC ASSESSMENT and RIVER CORRIDOR PLAN

2013-2014 December 24, 2014

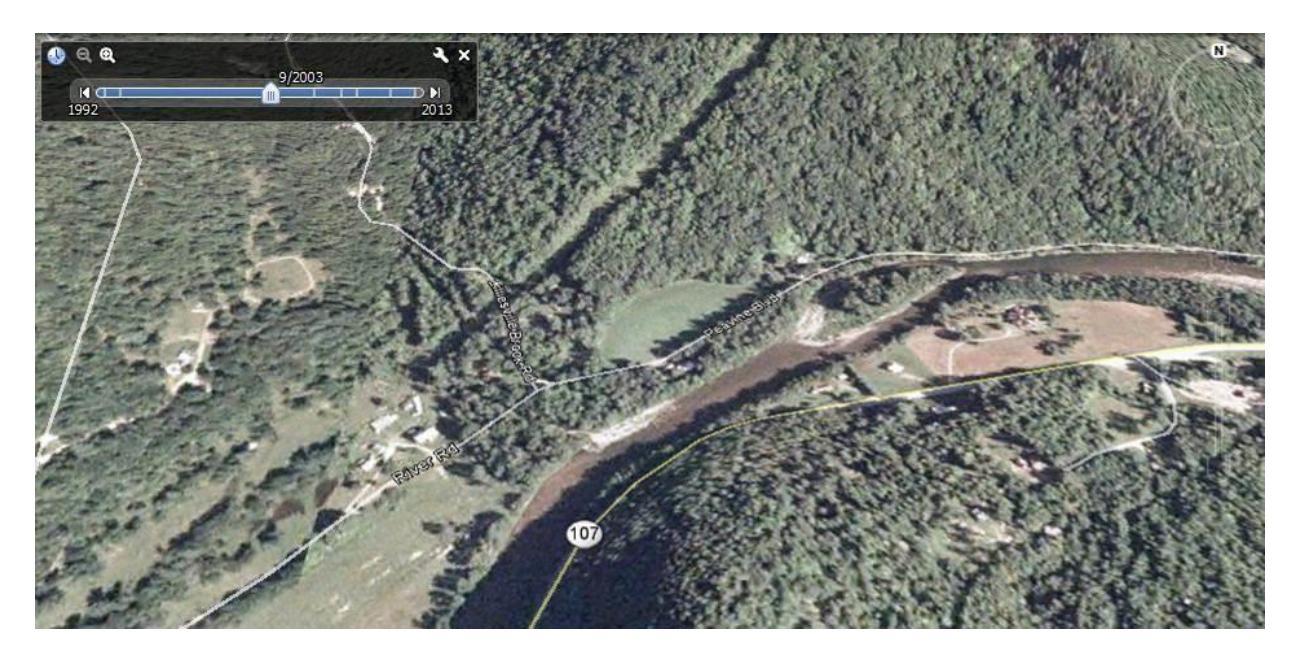
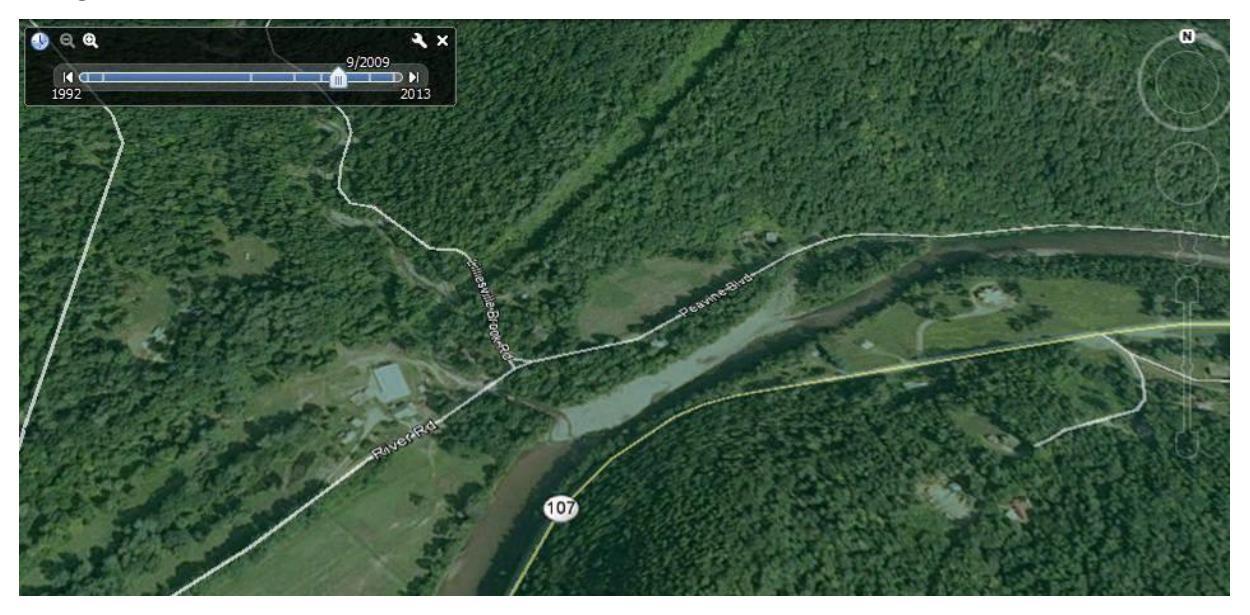
Figure 101. The same alluvial fan is shown with repeat "tributary rejuvenation" from Lilliesville Brook in Google Earth imagery from 2003 (above, following 1998 and 2002 flash flooding) and 2009 (below, following 2007 and 2008 flash flooding). Cobbles from this fan have been moved through reach R13 in high flows, contributing to rapid re-establishment of riffles and shallow rapids, as well as being dredged and used in road reconstruction.

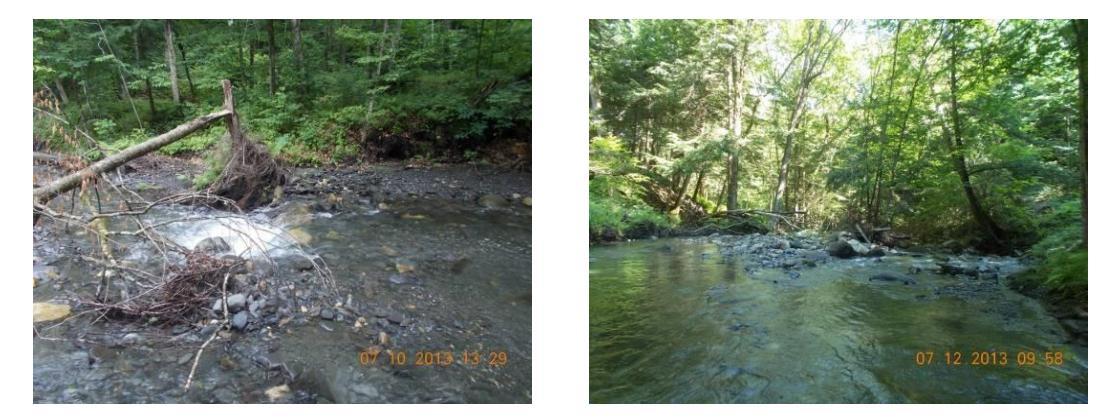
There is very little encroachment in segment R12-S2.01B, and no development. There is a history of timber harvesting, with old stumps right at the stream bank and old stream fords still visible. Storm impacts were primarily a function of soil erodibility and the steepness of the valley walls. Abundant depositional features included unstable side and mid-channel bars associated with steep riffles and braiding. Nick points and small head cuts were eroding through the steep riffles as the stream works to regain slope equilibrium and sort unstable sediments (Fig. 106). Abundant woody material falling into the stream after mass failures and bank erosion has led to numerous debris jams, flood chutes, and several channel avulsions (Fig. 106). Multiple terrace levels along the stream attest to past incision and successive floodplain abandonment.

Figure 106. Left: Headcut forming in head of a steep riffle as the stream works to find channel slope equilibrium and sort recently deposited sediments. Right: Channel avulsion, to the right side of the photo, caused by debris and sediment accumulation that blocked the original channel, to the left.

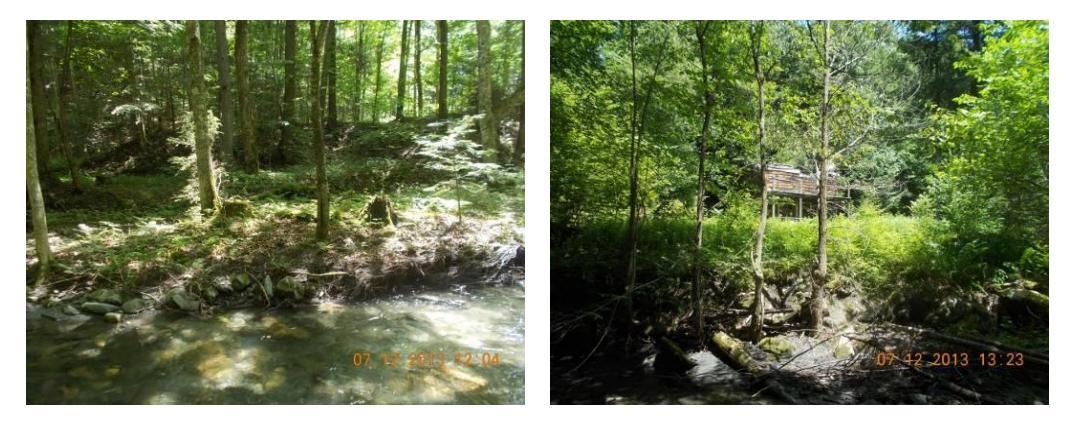
R12-S2.01C (2,153 ft. in length) is quite similar to Segment B. Valley type continues to be Narrow with extremely steep walls. Channel slope is similar and encroachments are minimal. Generally, the difference lies in more moderate recent storm impacts. Valley walls are still extremely steep, but less steep than for the downstream segments. Erosion is as common, but larger mass failures are more infrequent. Debris jams and unsorted, unstable sediment deposits are much less abundant. As in segment B multiple terrace levels suggest a history of incision, and old stumps and fords indicate periodic timber harvesting (Fig. 107). There is a small abandoned cabin on the stream's right bank (Fig. 107).

Figure 107. Left: Signs of periodic timber harvesting are common in segment R12-S2.01C. Right: A small cabin in the upstream part of segment C appears little used but has a small canopy opening maintained next to the stream.

River Segment	Project	Reach Priority	Watershed Priority	Completed Independent of Other Practices	Next Steps and Other Project Notes
R12- S2.01C	Protect River Corridors	Next Highest	Medium	Y	Municipal corridor protection to limit development; priority for further protections decreased by limited amount of accessible floodplain and low threat of development, with fewer mass failures (Than segment B) contributing to sediment loading
R12- S2.01C	Watershed Strategies	Very High	Low	Y	Municipal corridor protection to limit development; Drainage and stormwater management - storage within US watershed features

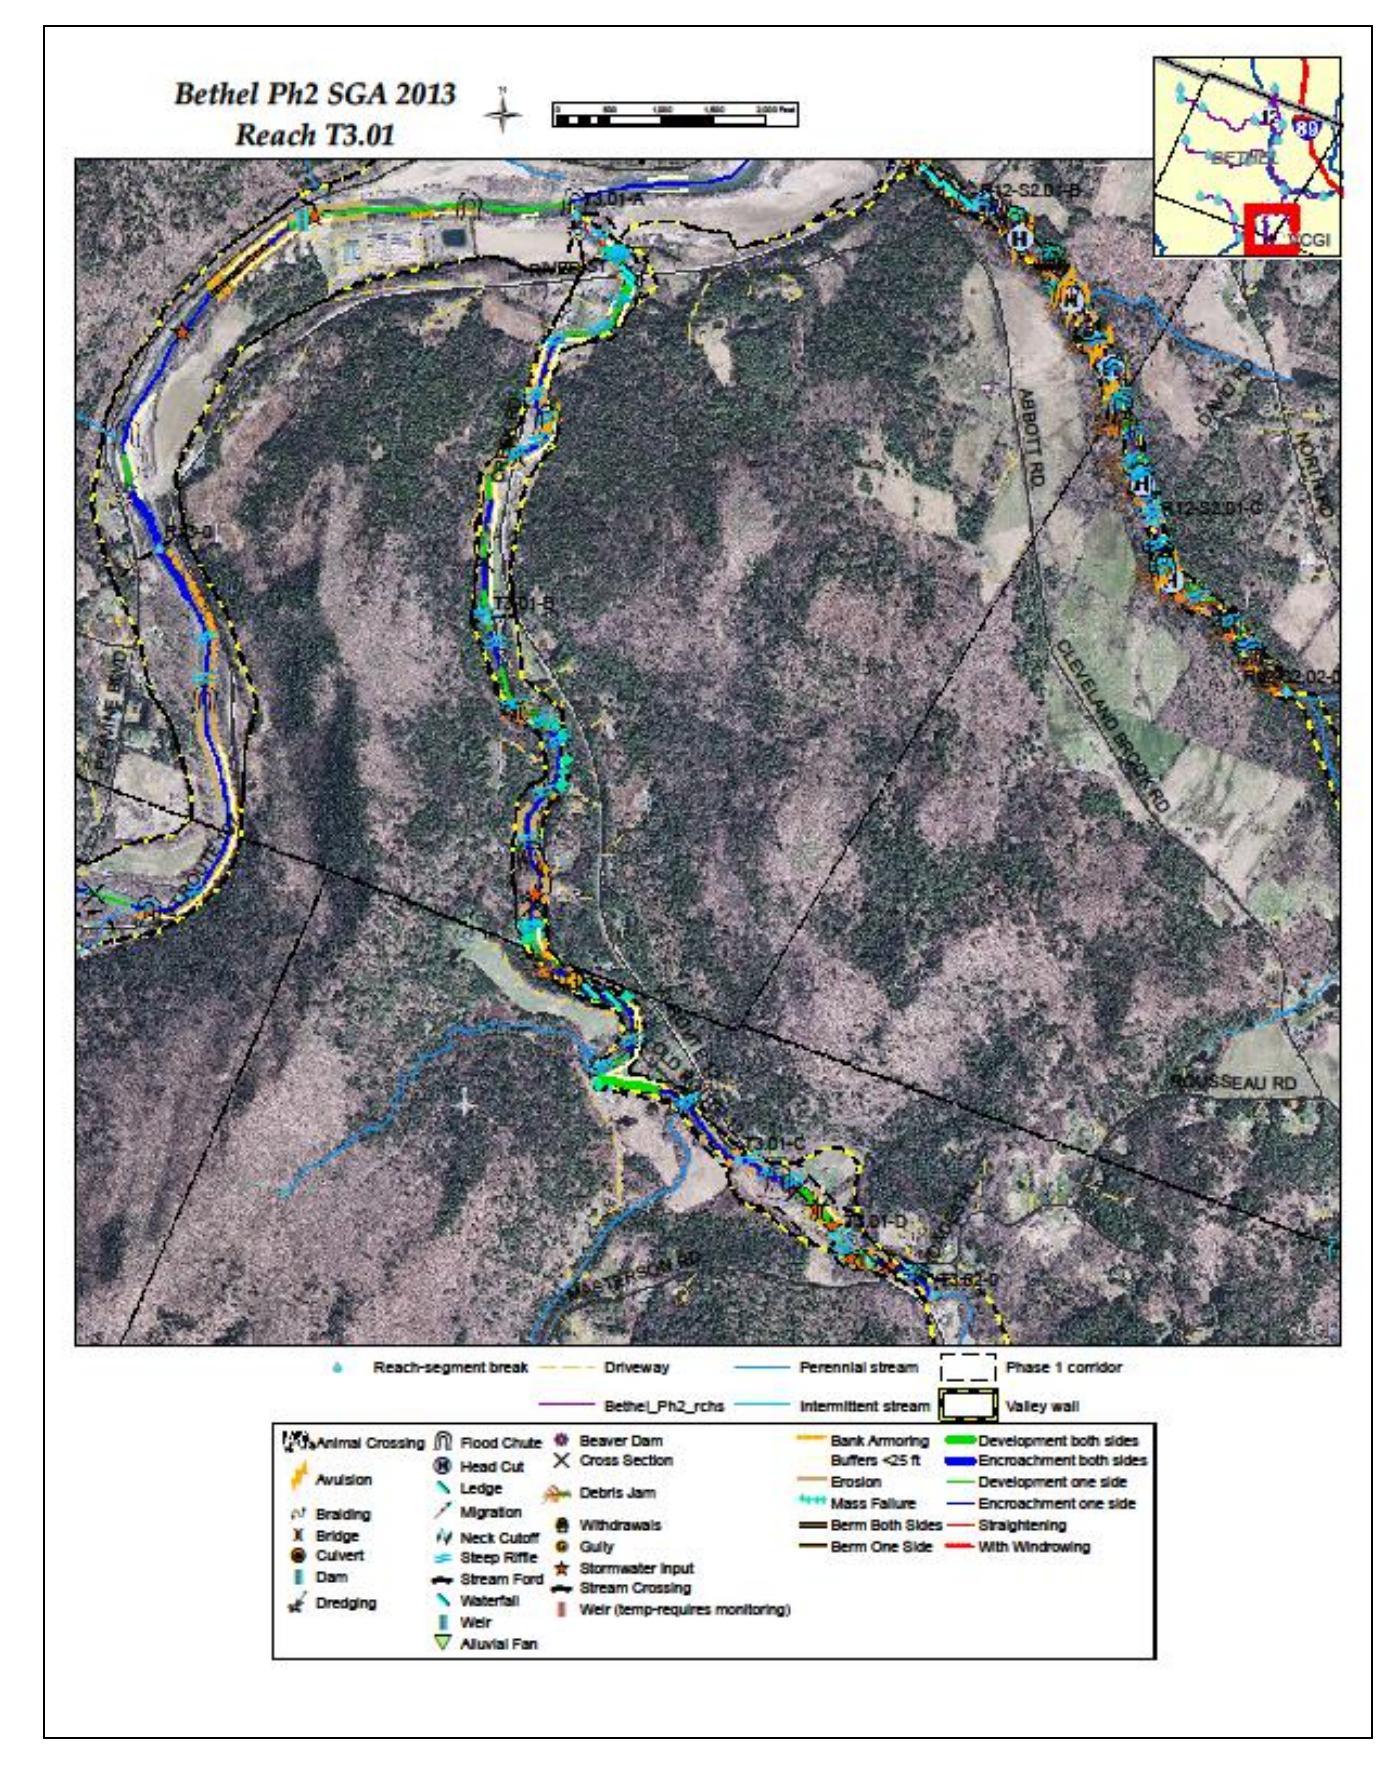
Figure 108. Bethel T3.01 reach map – Locust Creek.

Reach T3.01 flows through a deeply incised valley that roughly parallels Rte. 12 (and Old Rte. 12) for its entire length (Fig. 108). It was broken into four segments based primarily on differences in valley width, with differences in valley slope, corridor encroachments, and banks and buffers all providing secondary reasons for segmentation. Segment T3.01A is situated in a portion of the valley with the lowest channel slope and a Narrow valley confinement type. The valley further constricts in Segment B (Semi-confined), widens for Segment C (Very Broad), and narrows again in Segment D, which is a subreach in a naturally narrower portion of the valley (Narrowly confined).

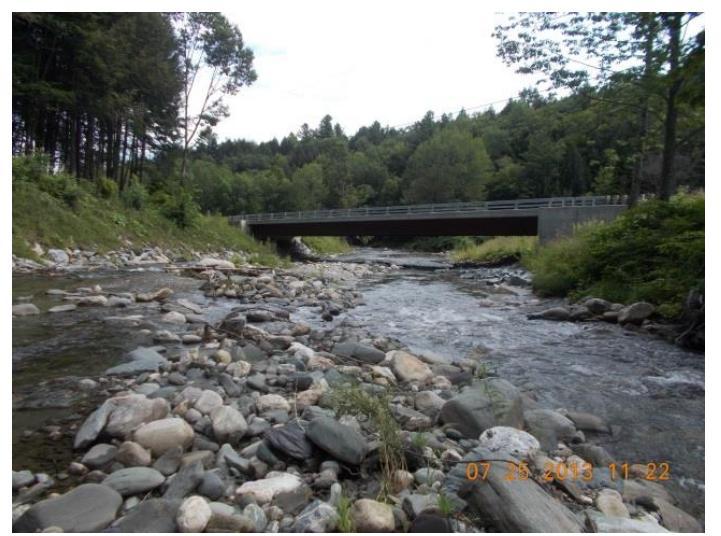
T3.01A experienced significant storm impacts during Irene. In the upstream portion of the segment a large bridge on Route 12 washed out and needed replacing (Fig. 110). Just downstream from this a major avulsion re-routed the stream toward the right valley wall and appeared to have damaged or swept away outbuildings off the right bank (present in Google Earth aerial imagery previous to 2011 but not afterward). There is very little woody debris in this segment of stream, indicating that it either was cleaned out following Irene, or that the volume of water moving through the segment was enough to move woody stems through; it appears likely that a combination of these represents a more complete story. Steep riffles and mid-channel bars, representing sediment accumulations that are too much for the stream to carry further or that have backed up at channel constrictions, are common in the segment. These depositional features indicate current instability and ongoing re-adjustments after high flow events. Multiple terrace levels are found alongside the stream in this valley, an indication of historic incision, and the stream shows signs of current widening that is mitigated somewhat by bedrock at the stream edges.

Figure 110. New bridge replacement after Irene damaged the former Rte. 12 bridge in segment T3.01A. Note the large diagonal bar in the foreground, typically a sign of stream instability and likely an indication of sediments from upstream mass failures dropping out as the high flows of Irene slowed when they were squeezed through the bridge. T3.01B (7,141 ft. in length) is the longest segment in the reach and is characterized by a Semiconfined valley with steep and extremely steep valley walls. Multiple terraces in the valley are an indication of historic incision leading to successive floodplain abandonment, likely due in part to post-glacial downcutting through the highly erodible deposits of a kame terrace on a "finger" of glacial Lake Hitchcock as well as the effects of extensive straightening related to location along two roads that have been major thoroughfares historically. In parts of the segment abandoned floodplain terraces are high enough to form an effective valley wall. The segment alternates between this condition and a "truly" semi-confined valley with natural valley walls; in terms of stream processes, the net effect is a semi-confined valley throughout the length of the segment. This section of stream crosses back and forth across Old Route 12, and each of the three bridges on this road constrict stream flow and sustained damage in Irene. The Bethel selectboard voted to permanently close one town bridge on this road after post-Irene repairs began to deteriorate and the Federal Emergency Management Agency specified that the bridge either needed to be replaced or closed (Cassidy 2012; Fig. 111). Road and and/or development encroachments are present along the entire segment and there is over 1,000 ft. of riprap along the stream banks. Most of the rip rap appears to be of insufficient size to prevent damage in future storm events (Fig. 111).

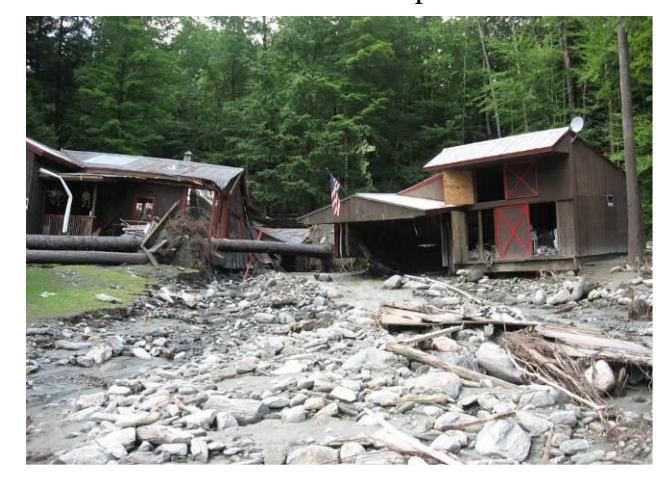
contributor to mainstem reach R13 in repeat flood events (see Figs. 100-101 in reach R13 description above in sec 6.1 of this report) and a number of structures along the stream have seen repeat flood damages (Fig. 114). The reach was heavily impacted in storm events in 1973, 1998, 2007, 2008 and again in 2011 (Tropical Storm Irene).

Figure 114. Flood damage following July 2007 flash flooding on Lilliesville Brook.

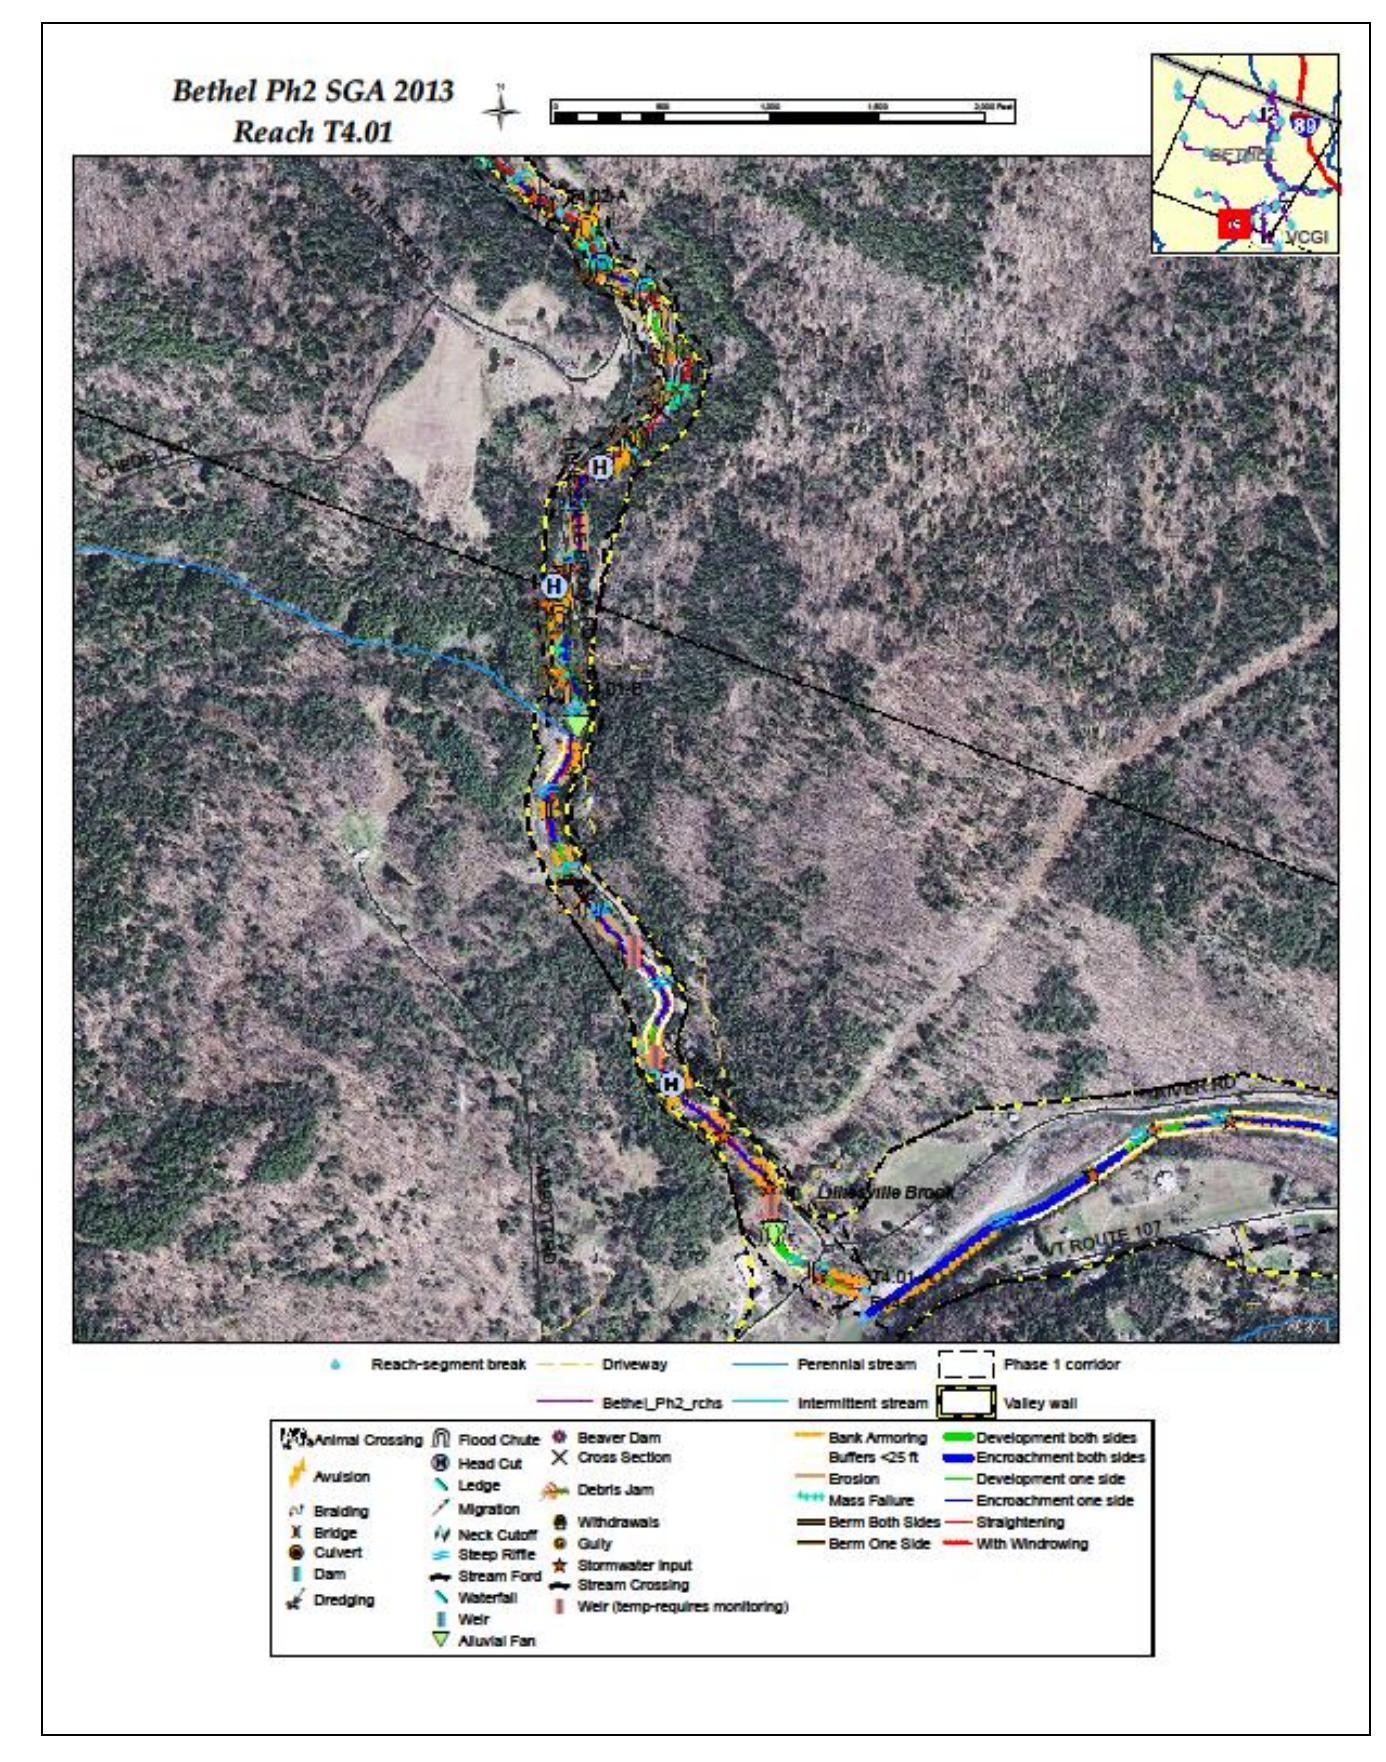
Figure 115. Bethel T4.01 reach map – Lilliesville Brook.

Reach T4.01 straddles the Bethel-Stockbridge town line (upstream in Bethel, downstream in Stockbridge) and runs roughly parallel with Lilliesville Brook Rd. for its entire length, passing under that road once and under River Road once near the base of the reach. This reach was divided into two segments based primarily on differences in degree of stream alterations, but also on differences in valley width, corridor encroachments, and banks and buffers (Fig. 115). An alluvial fan in the downstream portion of this reach has been a particularly heavy sediment

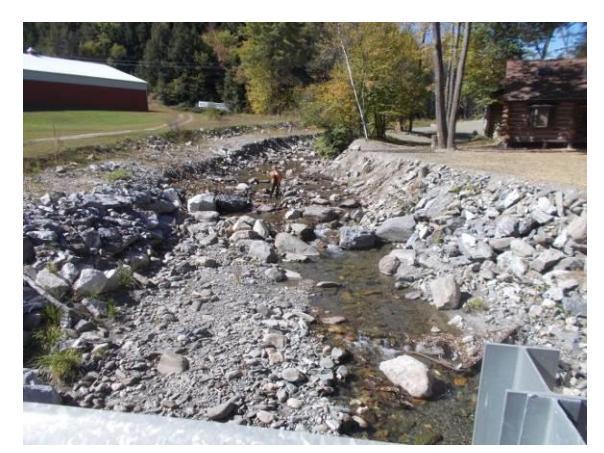
Segment T4.01A was entirely snagged (removal of wood) and dredged (removal of sediments) following Irene (Fig. 117). As part of a project to mitigate some of the effects of this straightening, rock weirs/steps were constructed to arrest further incision (and consequent loss of floodplain access leading to even greater stream power impacts in future flood events), and trees with root balls were buried in the stream bank to help stabilize the bank and create some habitat features as well as channel roughness to aid in diffusing stream power. Old terraces provide evidence of historic incision in this valley.

Figure 117. Upstream view from River Rd. bridge in T4.01A. The building on the right was rebuilt following Irene and a berm stretches along the river bank to protect that area. Channelization is distinct here and several constructed steps were placed to arrest further resulting incision. T4.01B (2,896 ft. in length) is found in a Semi-confined valley with extremely steep walls dominated by sandy, stony soils just upstream of the extent of glacial Lake Hitchcock. Approximately 50% of the segment has road or development encroachment along one bank, and like Segment A appears straightened along much of its length by virtue of this encroachment, effects of an undersized bridge, and historic incision (which is likely related to both human channel alterations and post-glacial downcutting through highly erodible sediments). Erosion and mass failures are extremely common in this stretch of stream, with approximately 40% of the segment exhibiting these on at least one side. Flood chutes are numerous, an indication that the stream adjusts to high flows by creating additional stream channels in the flood plain area. Forested buffers are found along both banks of this entire segment. Erosion has contributed to considerable buildup of woody debris in the channel, and during Irene this debris diffused stream power through 3 major avulsions into what appeared to be previously existing flood chute channels. Roughly 30% of the segment was snagged and dredged post-Irene.

T4.01A	Remove/ Replace Structures	Very High	Very High	Y	Though one bridge recently replaced at 36 ft width following damage in Irene, recommend bridges in this valley (due to topography, geology and hydrology) be sized at least 120 pct bkf (curve bkf 34, field-measured 53 ft); ability to pass wood and sediment critical in this setting - alluvial fan

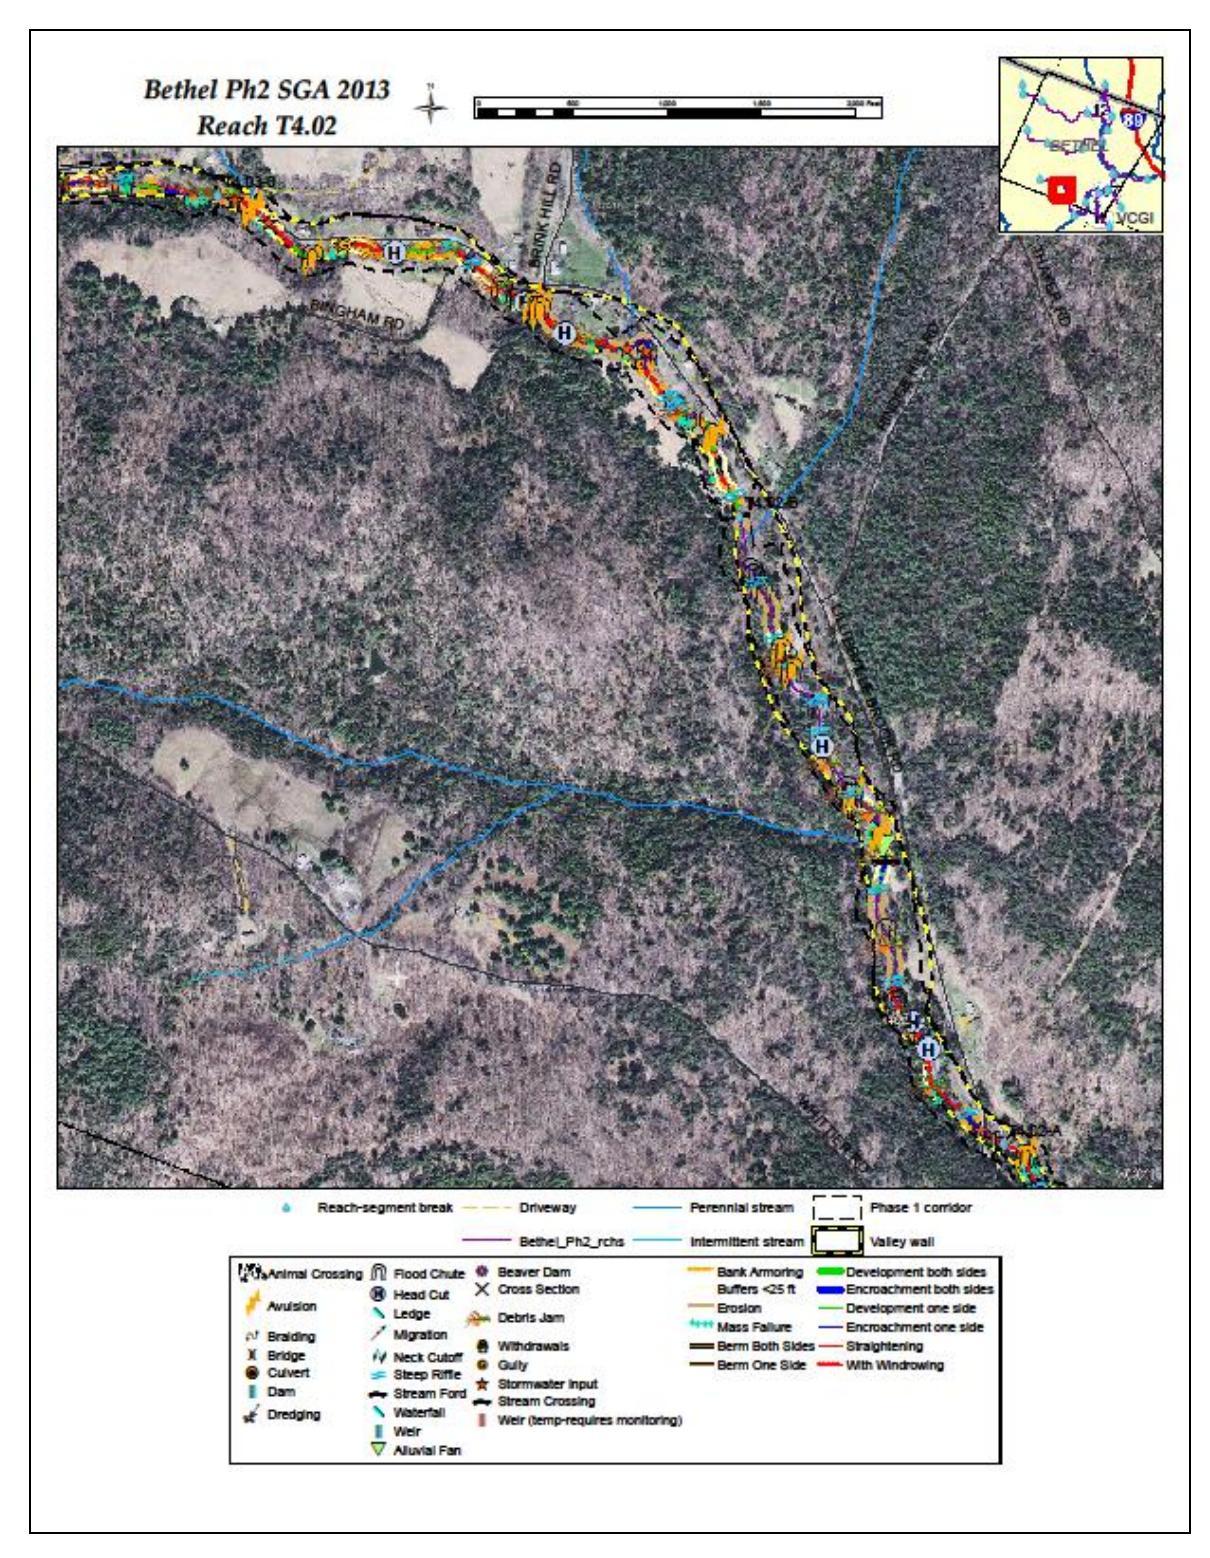
Figure 118. Bethel T4.02 reach map – Lilliesville Brook.

While Lilliesville Brook Rd. is still located parallel to the stream in reach T4.02, this reach generally has a bit more room between the road and stream than reaches up and downstream (Fig. 118).

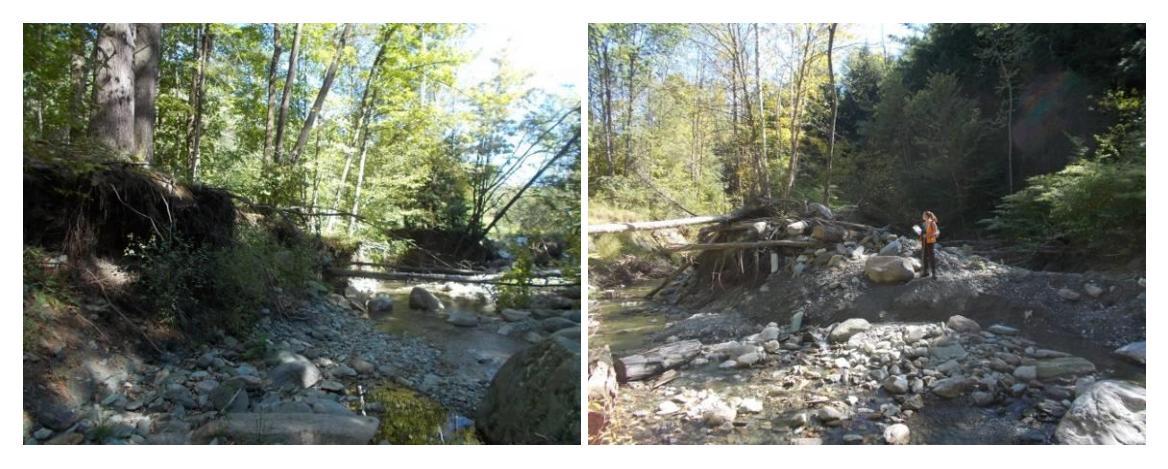
Tropical Storm Irene severely impacted many parts of segment T4.02B. Erosion and mass failures were common, with approximately 50% of the segment affected (Fig. 122). Impacts from Irene and other storms have been spread unevenly and affected by the distribution of riprap, encroachments and straightening effects, causing the stream to frequently alternate between narrow/incised and over-widened/aggraded. Unsorted sediment bars are common. Steep riffles were frequently associated with large mid-channel bars, with head-cutting beginning to occur at the downstream edge of the steep riffles. Flood chutes, debris jams, and large avulsions were also common (Fig. 122).

Figure 122. Left: bank erosion as shown here is typical in segment T4.02B where the stream has incised below the level of tree roots. Right: Large avulsions such as this are common in the segment.

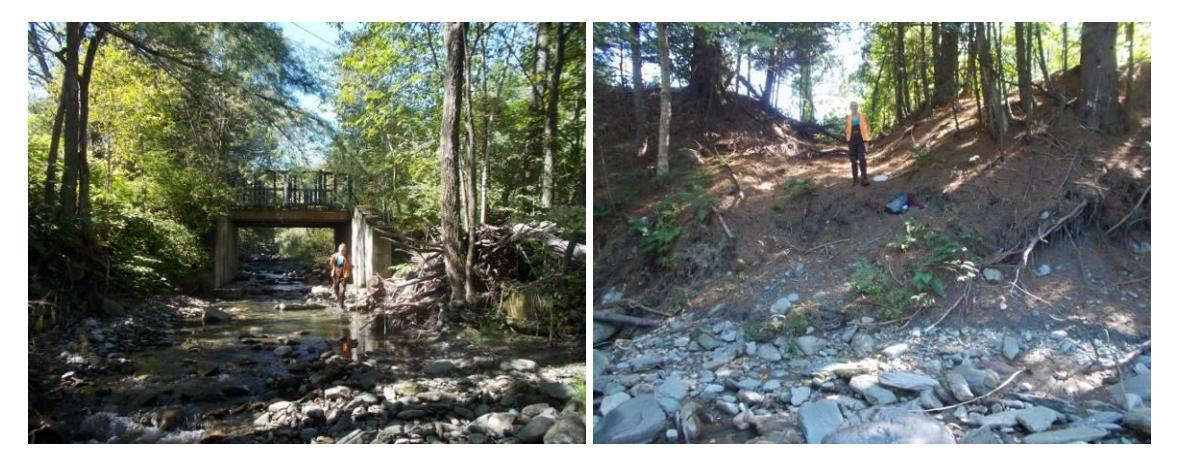
Two bridge constrictions and five stormwater inputs provide additional stress on segment T4.02B during periods of high flow. At least one of these bridges, and possibly both, washed out during Irene (Fig. 123). A landowner in the top part of this segment says the stream has flooded over Lilliesville Brook Rd., near her house, five times since 1974. Multiple terrace levels are an indication of historic incision and successive floodplain abandonment in the valley. A historic ford provides a good visual indication of how deeply this stream has cut below the grade of the original crossing (Fig. 123).

Figure 123. Left: Private bridge in T4.02B that may have washed out during Irene. There were definite signs that the stream crested the banks in this location. Right: Historic ford showing depth of incision since it was used.

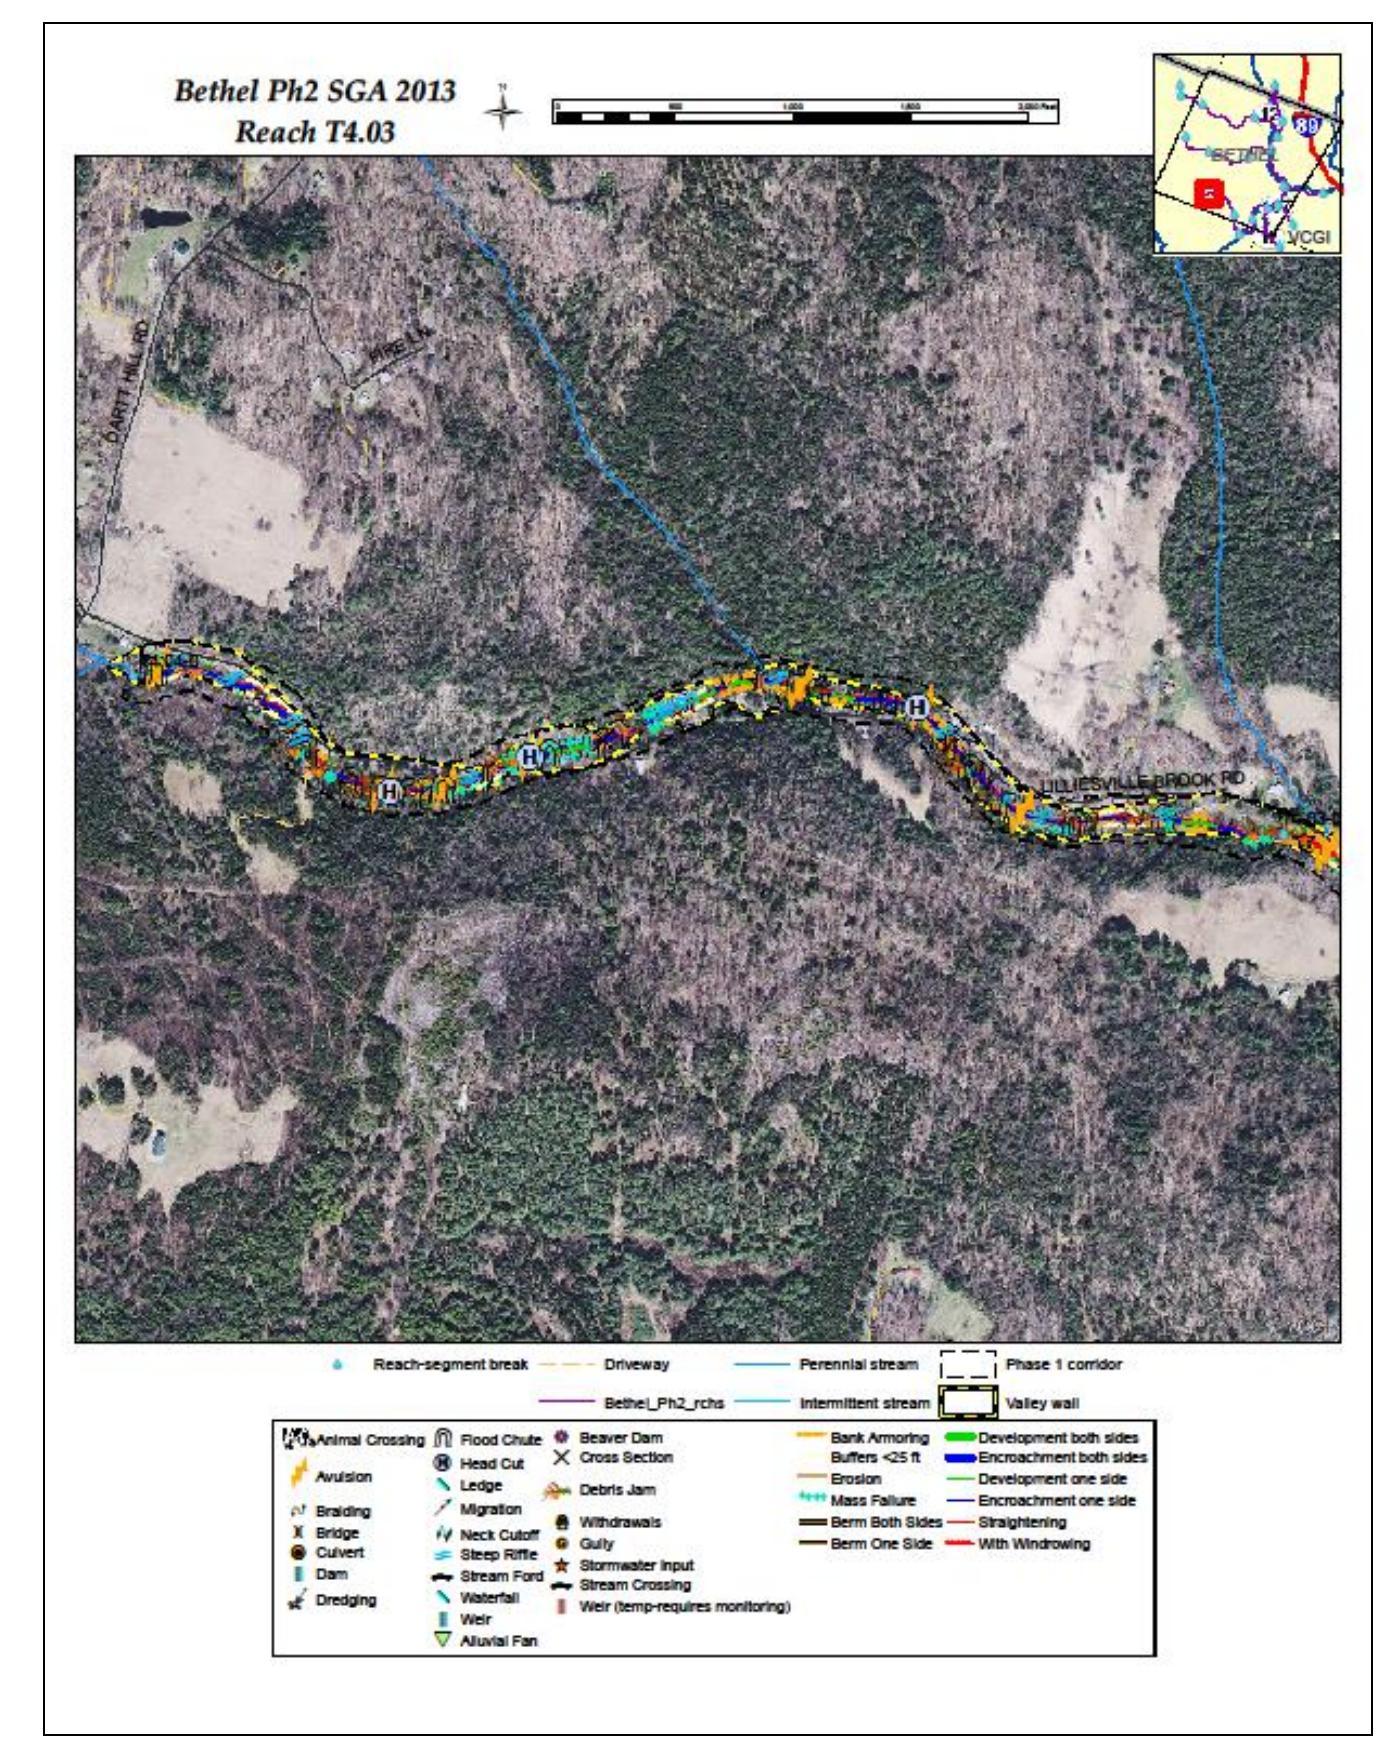
Figure 124. Bethel T4.03 reach map – Lilliesville Brook.

Reach T4.03 was not segmented for Phase 2 assessment. This section of stream gets progressively larger from top to bottom, as well as more impacted by recent storms and human activities, but there was no clear division to indicate segmentation. The stream here runs through a narrow valley with extremely steep walls in close proximity to Lilliesville Brook Rd. through most of its length (Fig. 124).

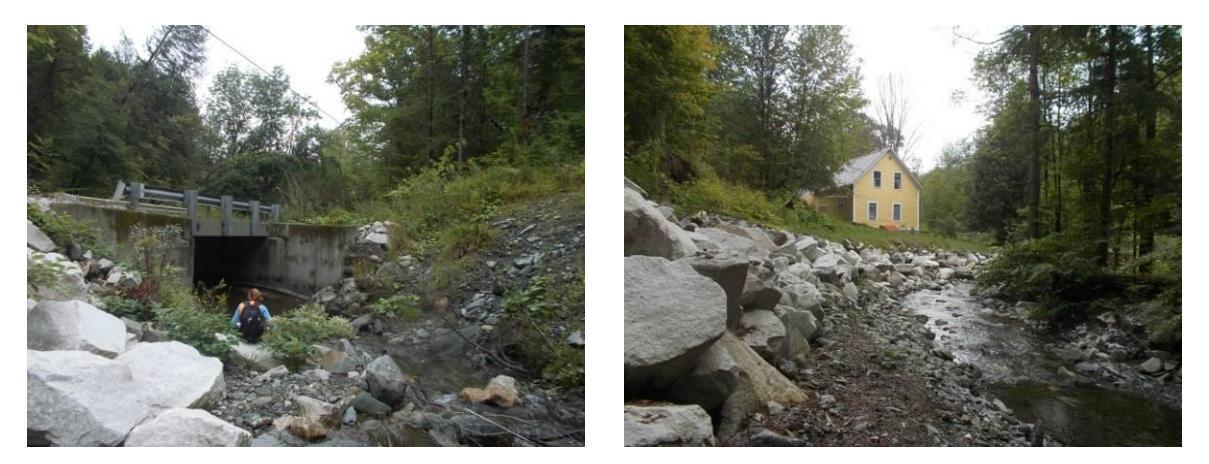
All of the bridge crossings in T4.03 create channel constrictions (the largest ones, despite being sized adequately, create constrictions due to the angle of alignment to the stream reducing the effective width of the structure). Several of these bridges were over-topped and severely damaged during Irene (Fig. 125). Surface water inputs from road ditches (9 inputs) add additional flow to the stream. Development is frequently located close to the stream channel, and there have been recurrent conflicts with stream processes during periods of high flow (Fig. 125). Dredging and snagging were common activities post-Irene.

Based on predicted channel bankfull width (22 ft) from regional hydraulic curves (a function of drainage area), three of the bridges are sized at ~70 percent stream bankfull width (at typical 1.5-2 yr. peak flow levels), one at 95 percent and one at 135 percent (though the latter bridge effective opening is significantly reduced by the angle of alignment to the stream and the

combined effects of riprap and sloped fill under the abutments). Based on field measurements taken at the Phase 2 "representative cross-section" for this reach (29 ft.), these figures drop to ~55-60 percent for three bridges, one at 70 percent, and one at 100 percent. Due to the topography and hydrography of this portion of Lilliesville Brook it is highly recommended that bridge replacements in this area be sized at least 120 percent of bankfull width to accommodate passage of wood and sediment as well as water. Failure to size bridges adequately continues to contribute to hourglass and Venturi effects at undersized structures.

Figure 125. Left: This bridge on Lilliesville Brook Rd. was damaged during Irene, but remained standing while the road washed out on both sides. According to landowner reports, this was a common occurrence with the bridges in this reach. Right: Bank encroachment and recent riprapping, with associated dredging, post-Irene.

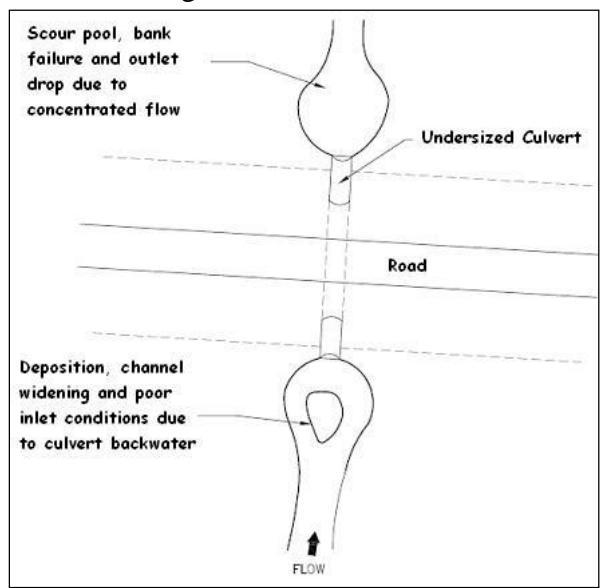
Personnel from the Green Mountain Forest District of the USDA Forest Service documented a number of recently installed culverts, sized at 100 percent stream bankfull width or larger, that sustained no damage during Irene despite having had to pass significant amounts of large woody debris (Kirn 2014) Because these culverts were sized this large, they limited the "hourglass effect" associated with undersized structures (Fig. 126) that tends to funnel and accumulate sediment and woody debris just upstream of a structure, while downstream of the structure the heightened stream power of "tailwater" being accelerated after being forced through an undersized opening tends to cause amplified erosion that typically needs to be controlled with bank armoring.

Figure 126. "Hourglass effect" at undersized stream crossing structures tends to accumulate sediment and woody debris in an over widened channel just upstream of the undersized opening, while scour due to heightened erosive power of "tailwater" forced through the structure over widens the channel just downstream (Kirn 2014; Bates and Kirn 2009). Elevated erosive power of high flows constrained to the current channel can be expected to continue to widen the stream (and recruit more wood) in reach T4.03 since aggradation has not brought the stream bed up to a level that can regain historic flood plain access across which high flows can be diffused. Undersized bridges are likely to continue to be in recurrent conflict with inevitable stream processes on this brook, and continued dredging and snagging are likely to continue to increase the impacts of heightened stream power. Adequately sized structures and reduced levels of encroachment are likely to become increasingly cost-effective with the more frequent recurrence of intense downpours forecast for the northeast US in the decades ahead.

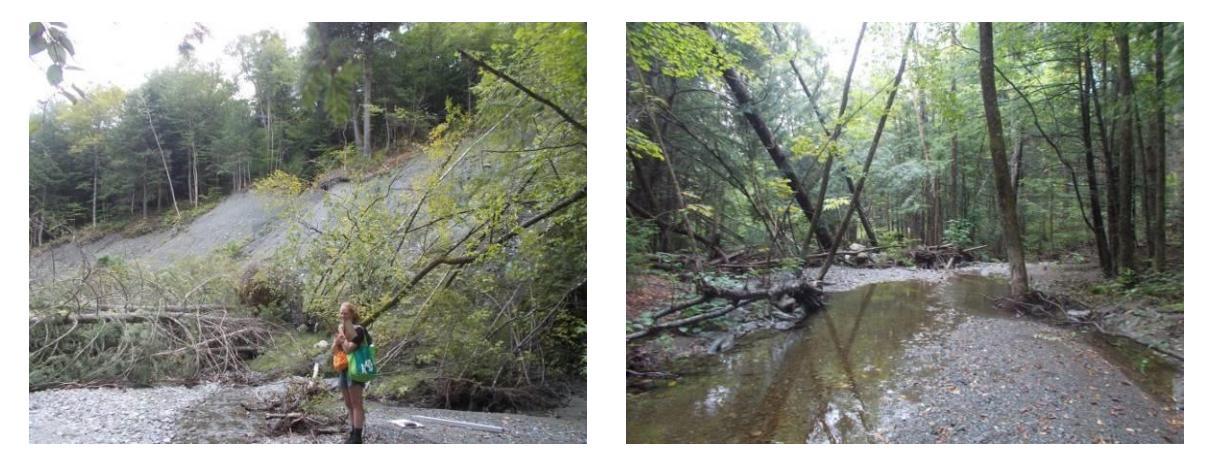
Forested buffers dominate the stream corridor of reach T4.03, with residential development secondary. Recent storm damage has eroded banks, caused mass failures and deposited abundant woody debris in the stream channel. Erosion and mass failures now affect approximately 35% of the reach (Fig. 127). Riprap placed to prevent further erosion is found in another 25% of the reach. During Irene and subsequent high flows, woody debris from tipped over trees left numerous debris jams, large un-sorted sediment deposits, and split channels and channel avulsions (Fig. 127). The stream is in the process of adjusting to all of these recent impacts.

Figure 127. Left: Mass failure in the downstream end of reach T4.03. Several of the mass failures in this reach were of this magnitude. Right: The debris jam in this photo retained sediments upstream, bringing the channel bed close to the flood plain level, as well as causing a channel split with erosion and headcutting downstream in the newly formed second channel.
